PRELIMINARY INVESTIGATIONS OF LANDSLIDES ZONES IN KANGRA AND CHAMBA REGION AS PER NOTIFICATION NO REV (DMC) (F) 11-09/2021- LM DEPARTMENT OF REVENUE (DM CELL), GOVT OF HIMACHAL PRADESH.

PROF. AMBRISH KUMAR MAHAJAN

CENTRAL UNIVERSITY OF HIMACHAL PRADESH

DATE: 26TH February 2024

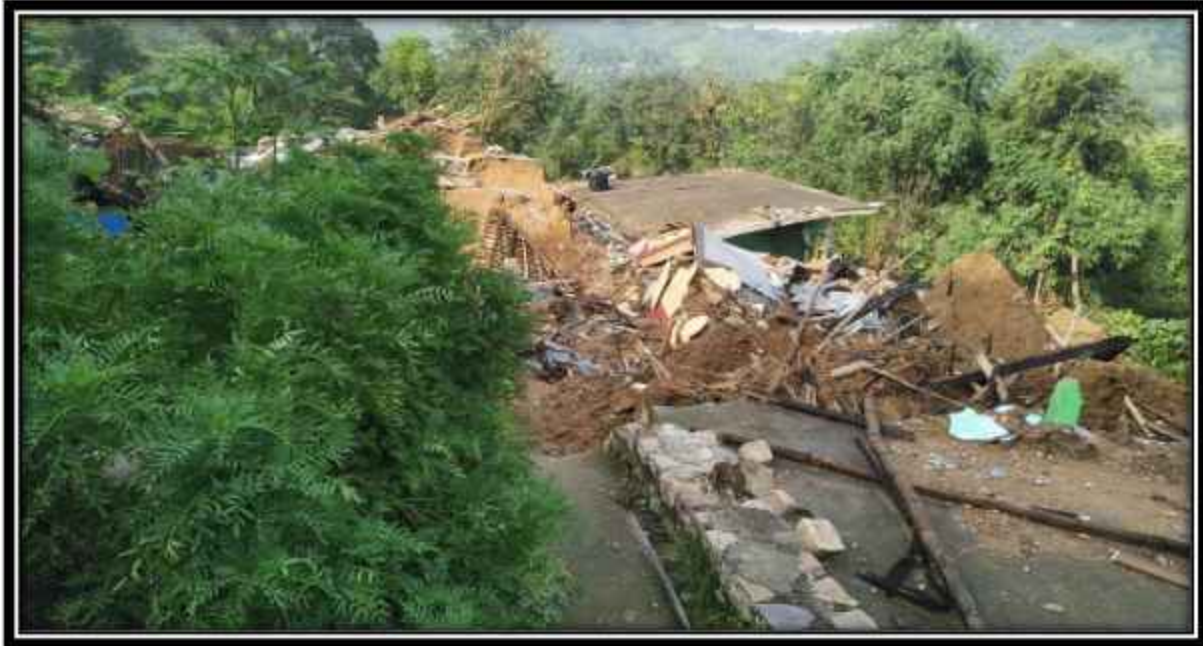
Fig 5 showing damage scenario after landslide at Parmar Nagar, Dheera-Nora region

During the field investigation, three main scarps zones have been identified and the data has been collected for the all using both physical investigation and Lidar survey. There has been extensive damage reported in this area, numerous houses have been collapsed, the agricultural land found subsided and caused devastation to crops (Fig.5-6).

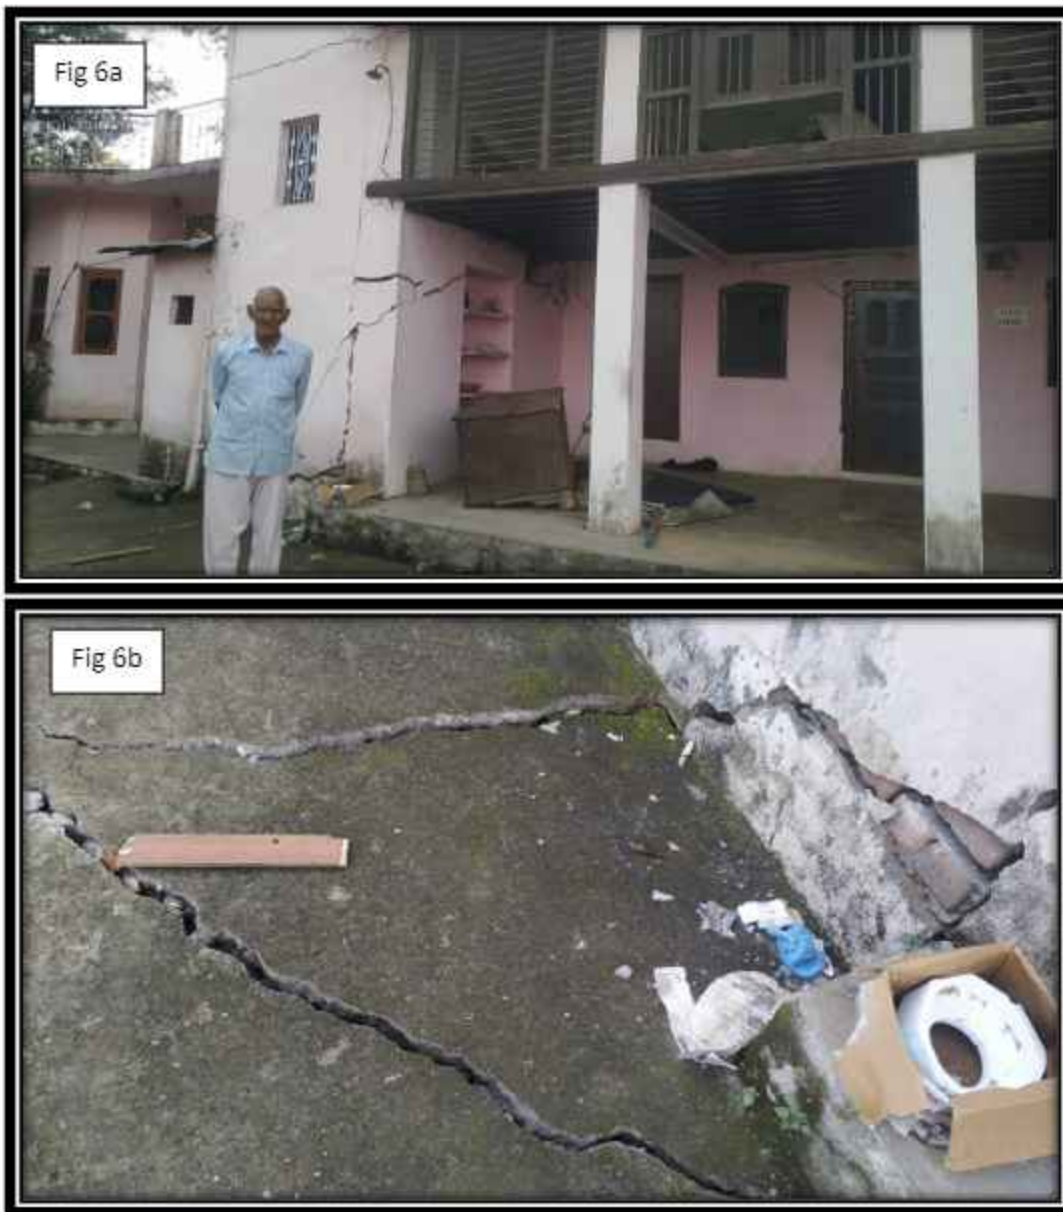
Fig 6 (a) and 6 (b) showing damages caused to the houses during the landslide incident in Parmar region. The development of cracks in the walls and floor indicated subsidence cracks.

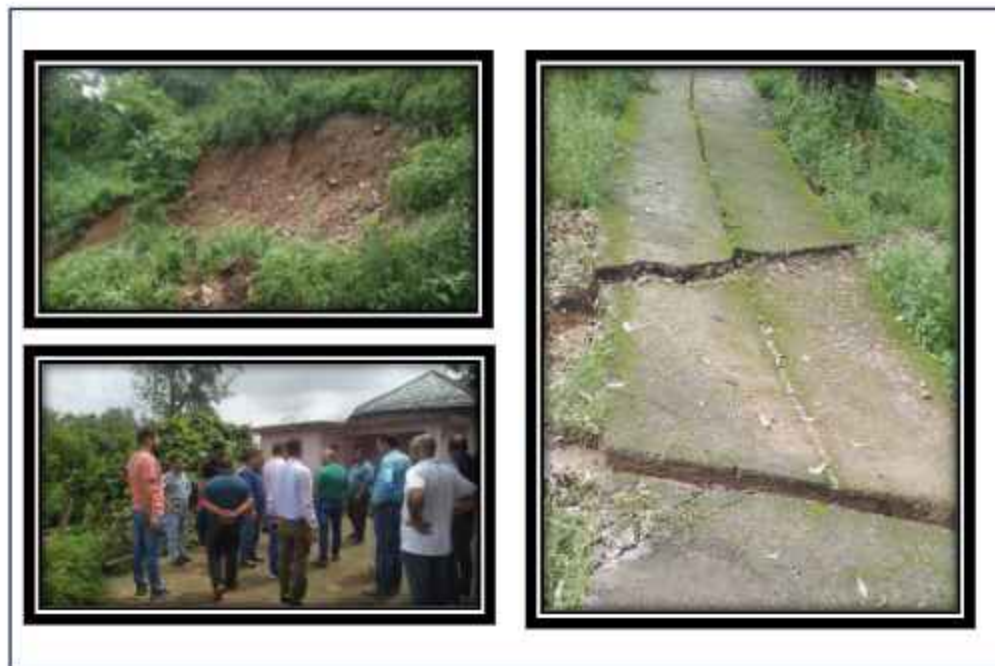
rooms and toilet and it means daily 6000 lt of water goes directly into the soil (alluvial soil) which is much more than the infiltration due to rain fall. However, due to porous nature of the soil the area could sustain sliding in the past because water seeps downs the slope due to high porosity nature of the gravelly soil. However, this year's continuous rain fall since April 2023 has led to over saturation of the soil and allows the landmass to subside along the slope angle (steep slope angle $> 65^\circ$). Thus, the soil loses its frictional strength and moved along the slope. Secondly the Nalla flowing at the toe of the village also added to movement of the landmass because of removal of material from the toe area. Due to heavy rainfall in the past three months, the soil has achieved saturation level and resulted in water logging condition. The steep slope angle and trend of the contours decides the scarp zone which gave rise to the present shape and disastrous scenario in that region. According to the preliminary field observation, the first slide one near the main Parmar Nagar is not suitable for any residential purpose any more (Fig. 4-5). At the same time the second zone where one house had developed wide cracks also falls within the scarp zone and found to be unsuitable for the residential accommodation as the land mass may move any time this year or in subsequent years due to the slope angle and heavy burden of the material which has already moved by few meters (Fig 7).

Fig. 7 Shows the scarp in the second slide zones and house with in the slide zone.

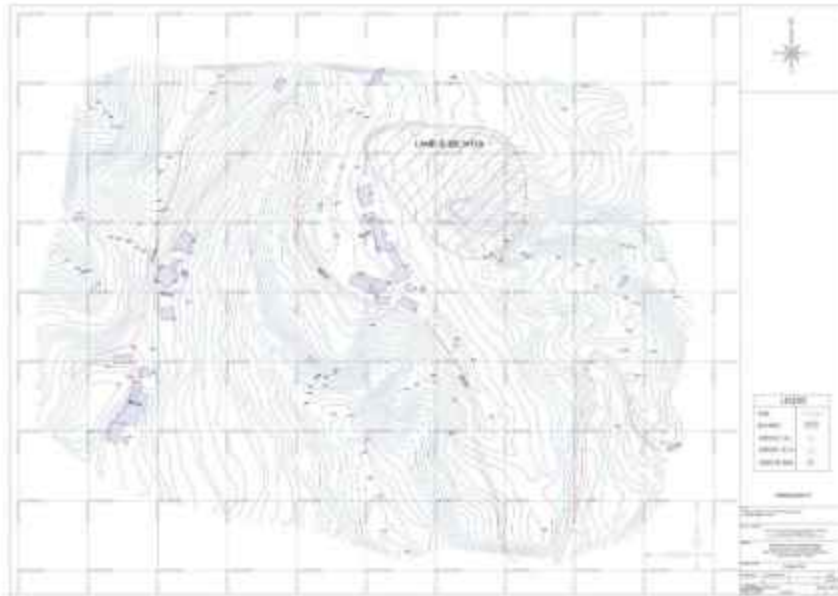
building at present as the contours have taken a turn towards the east from the corner of that house (Fig.8). However, further detailed studies are required to be done to furnish complete reports of the third slide zone, which may require detailed investigation on geotechnical and geophysical ERT and seismic survey of the slide zone. The Lidar survey report is still awaited as it needs three four days for processing which will be submitted on its arrival. Hope the administration may be benefitted by the preliminary investigation and suggestions provided and will help to provide assistance to the local communities.

Fig.8 Shows the contour map landslide portion of slide zone 3 with contours of the Parmar Nagar

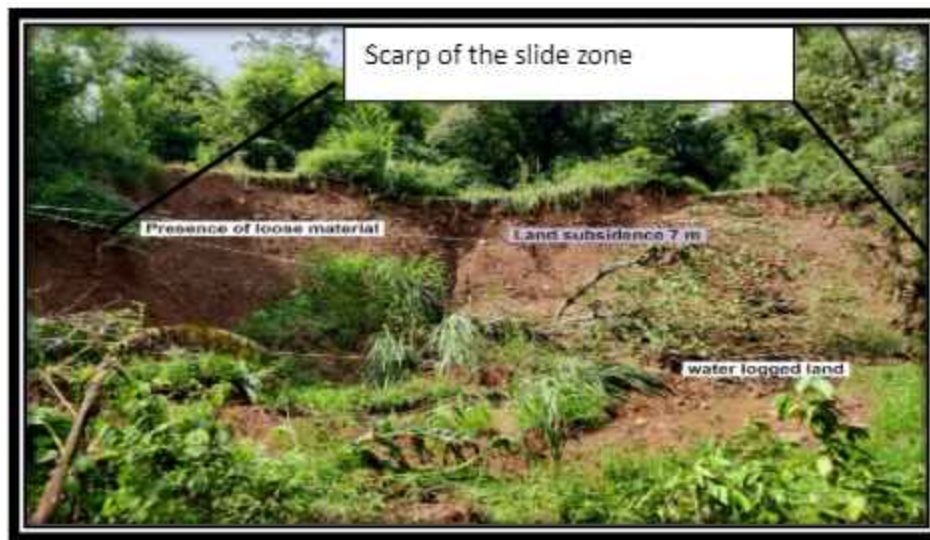
Fig 9 showing full panoramic view of landslide event and subsequent land subsidence at site no 3

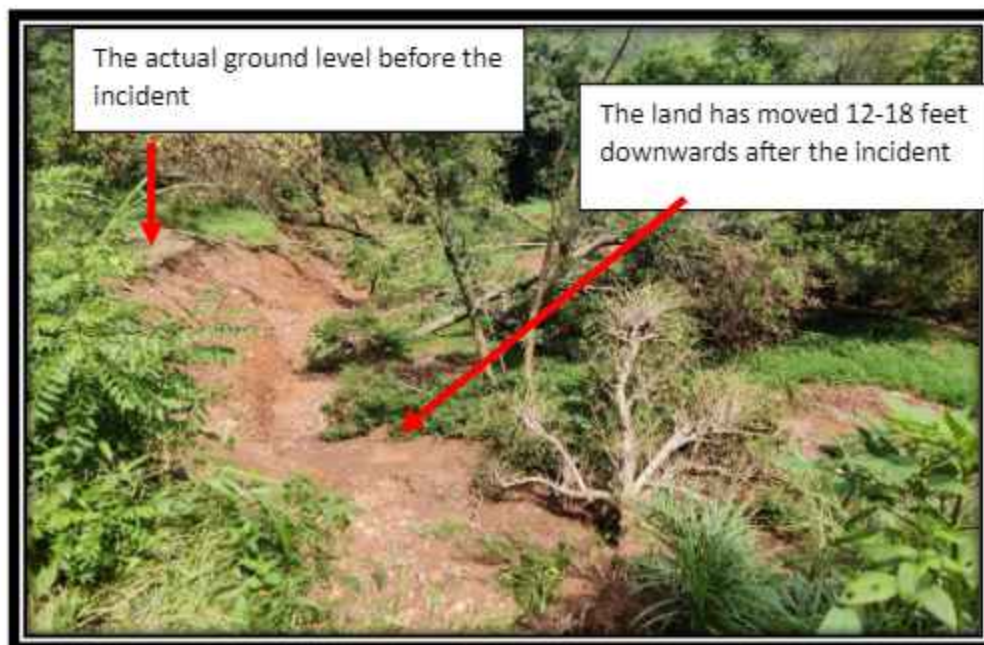
Fig. 10. Showing development of wide fissures in the agricultural land with titling of trees indicating deeper slip surface.

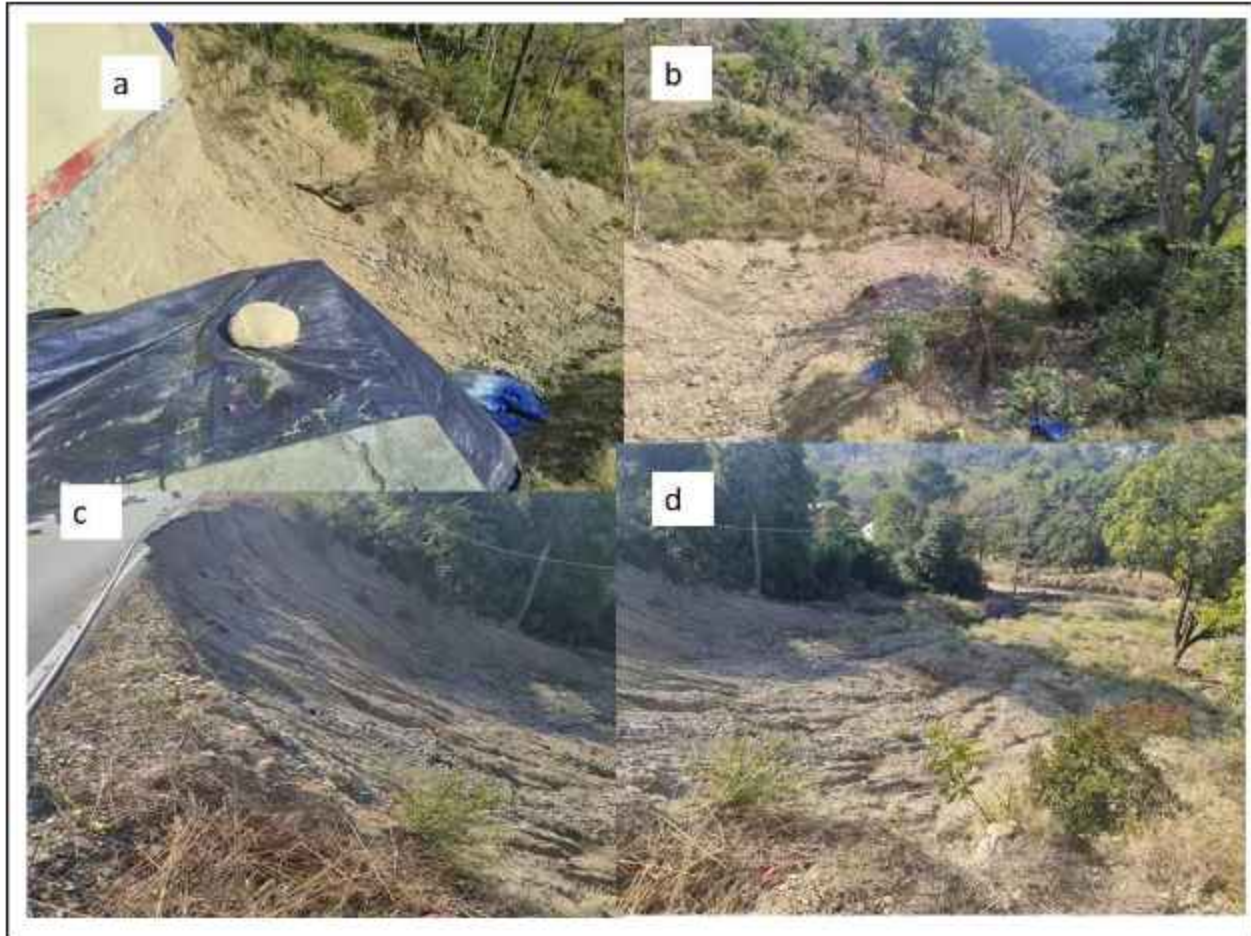
This site is located at Baloona village on road head side (at coordinates 320.27' N and 760.19' 49" E), in which retaining wall of the houses was found displaced downslope on August 14, 2023 (Fig. 11). The movement was attributed to the steep slope angle, poor frictional strength of the soil and continuous rainfall. The retaining wall, constructed by the owner, proved inadequate given the slope angle and the loose, gravelly soil lithology, leading to its failure under the combined influence of gravity and heavy rainfall. Actually the load of the retaining wall was quite high and it was on the crest of the slope, which itself increased the load on the soil and slope underneath. Despite the soil's poor water retention capacity, its strength is also compromised.

Fig. 11 Shows the lithology of the slide zone, characterized by gravelly soil, is evident in the displacement of the retaining wall observed on the upper right-hand side, which occurred due to the combination of heavy load and rainfall on August 14, 2023. The upper left photo illustrates the slope angle and pattern, while the lower picture depicts a slide along the National Highway in the same village, just a few meters downstream. Once more, the inability of the lithology to withstand the high moisture content in the gravelly soil resulted in a loss of frictional strength, leading to downslope.

Recommendation: To safeguard the area, a recommendation is to install 5-6 bench retaining walls downstream from the riverbank. The lower retaining walls should be constructed from concrete, extending their length along both sides of the hillock followed by Gabion wall to have enough porosity for water to move.

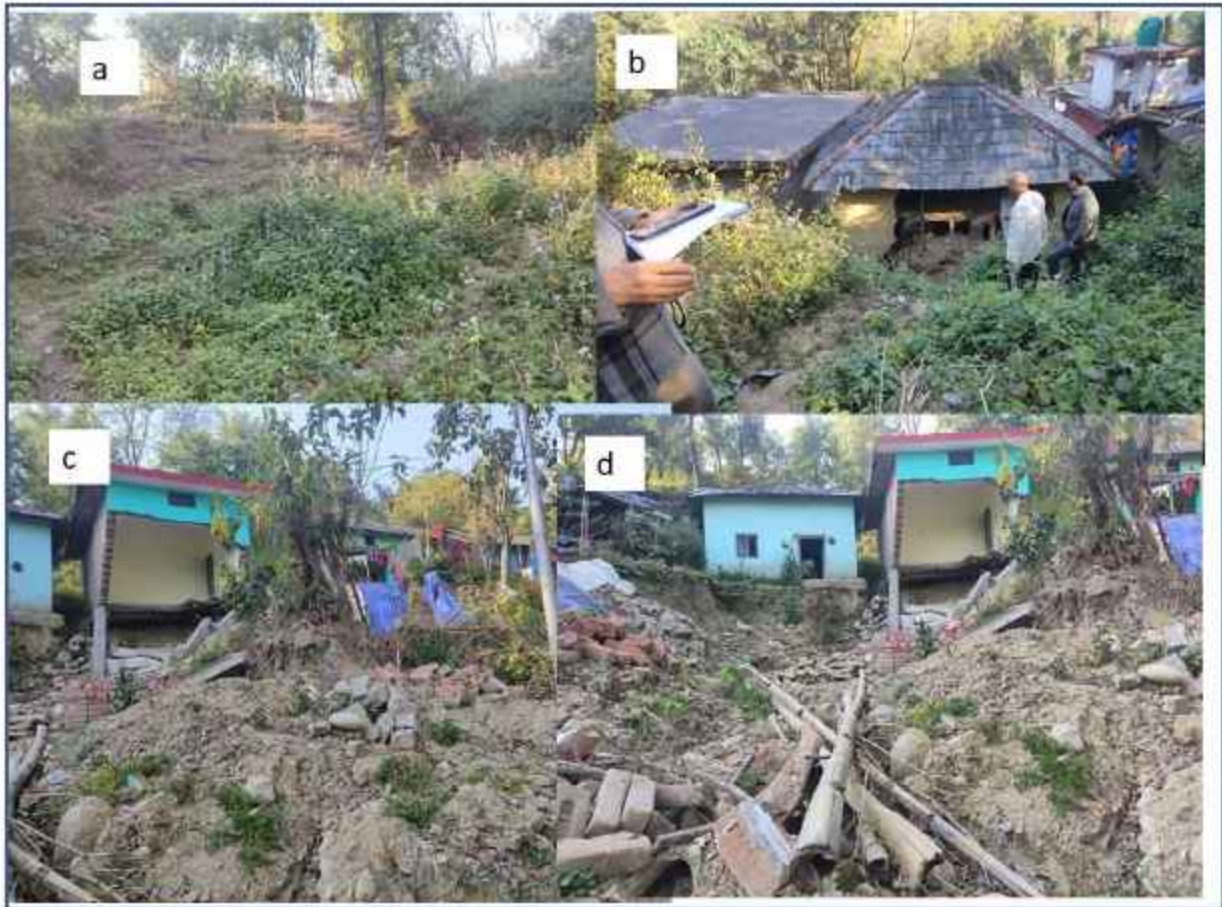
away from the houses. Consequently, water became trapped on the rear side of the concrete structures, particularly affecting areas with weaker lower portions (Fig.12). Conversely, nearby mud houses with sturdier foundations were better equipped to withstand the pressure of the waterlogging. However, the concrete buildings bore the brunt of the flooding. To mitigate the risk of future waterlogging incidents, it is crucial to install a proper drainage system at the rear of the houses to redirect water away from the structures.

Fig. 12 Shows the damage cause to the houses in Gurthali village a) shows the slope angle and ridge from where water came after heavy rain fall b) the back side of the houses where water was blocked, the mud houses could sustain the pressure but concrete houses could not sustain the water pressure due to soft storey at the bottom c and d) damage cause especially removal of lower portion of concrete house and havoc caused by blocked water in the down side agricultural land in front of the houses.

Recommendation: Proper drainage system needs to be planned to avoid blockage of any water behind the houses along the slope.

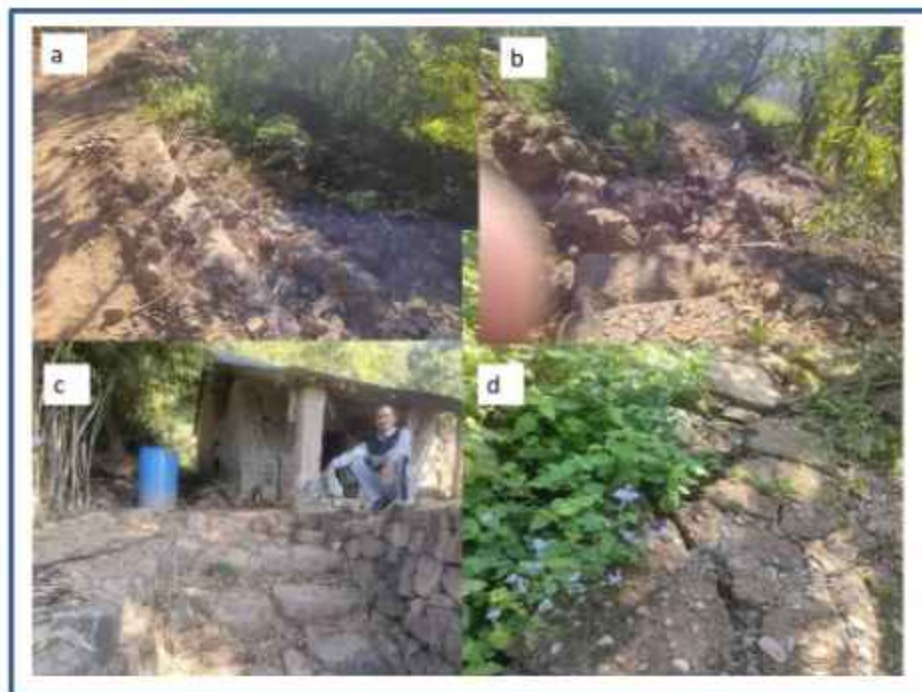
The displacement of the upper scar was initiated by movement from the toe region and tectonic disturbances, resulting in the displacement of buildings by several feet and causing damage to houses, village pathways, and extensive cracks in concrete walls (Fig.13 &14). The landslide is of a rotational nature. Residents reported observing wide cracks in the northern part of the hillock prior to the landslide movement, possibly indicating tectonic activity. Given the tectonic activity in the frontal part of the Himalayas, the role of tectonic disturbance cannot be discounted in the region.

Fig. 13 a) Subsidence of retaining wall of the village path b) rugged and uneven slope due to displacement of material c) subsidence crack on back of house and d) damage to the cemented path of the village. All these features are developed due to deeper slip surface and movement along that surface.

- This slide needs to be studied in detail in respect of tectonics, estimating slip surface depth and its geometry and situation of material and its erosion level at toe area using both geophysical, geotechnical and geological studies.
- Improving drainage system in the region and filling of land fissures with soil uphill will not allow the water to percolate along the slip surface and protect the slide. Since the debris material is

- Further the water from springs which is being spread in landmass should be channelized to follow the natural drainage.
- Sewerage system in the village needs to be taken care to avoid directed infiltration of water from houses to landmass which otherwise reached the slip surface, The rain fall only triggered the slide but otherwise the condition of sliding had been developed by our poor drainage system and sewerage system.

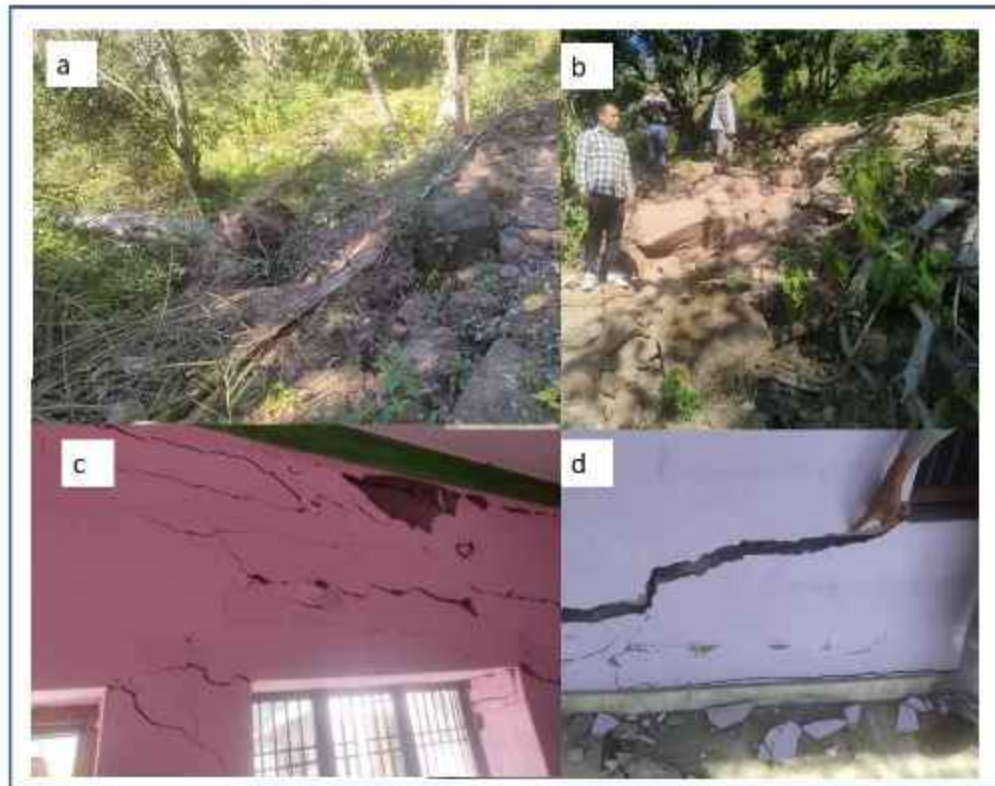
Fig.14 Uprooting of trees and displacements of roads and it's downwards movement suggesting deeper slip surface b) Development of cracks in walls suggesting movement direction

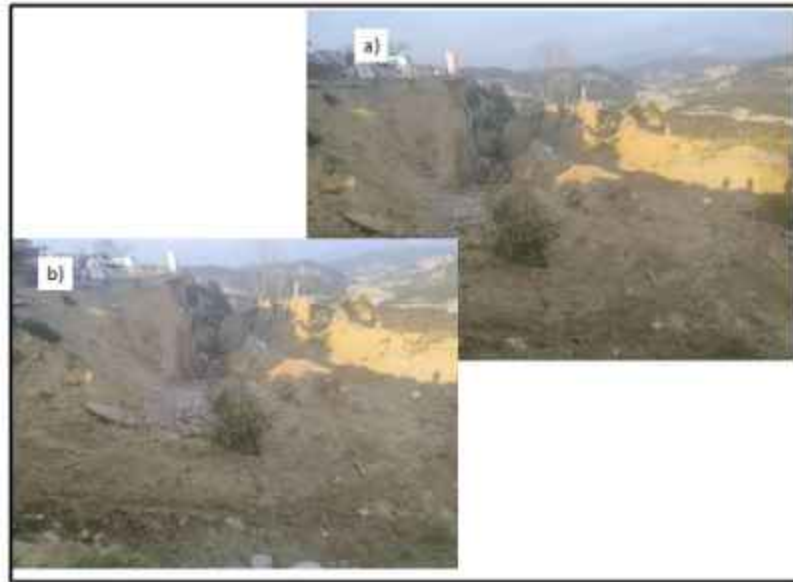
Fig. 15 Sandstone rocks get displaced along the fissure and caused disastrous impact in the village. All houses located on this portion of the sheet like rock also displaced.

Causes: Neo-tectonic activity 2) increased mining activity 3) poor drainage system 4) and of course high intensity rain fall which trigger the slide.

Recommendation: Needs to protect the toe region from mining activity, avoid the houses from house hold water to enter into the slide mass and have proper drainage system to avoid water to enter into the sandstone rock fissures to protect the land.

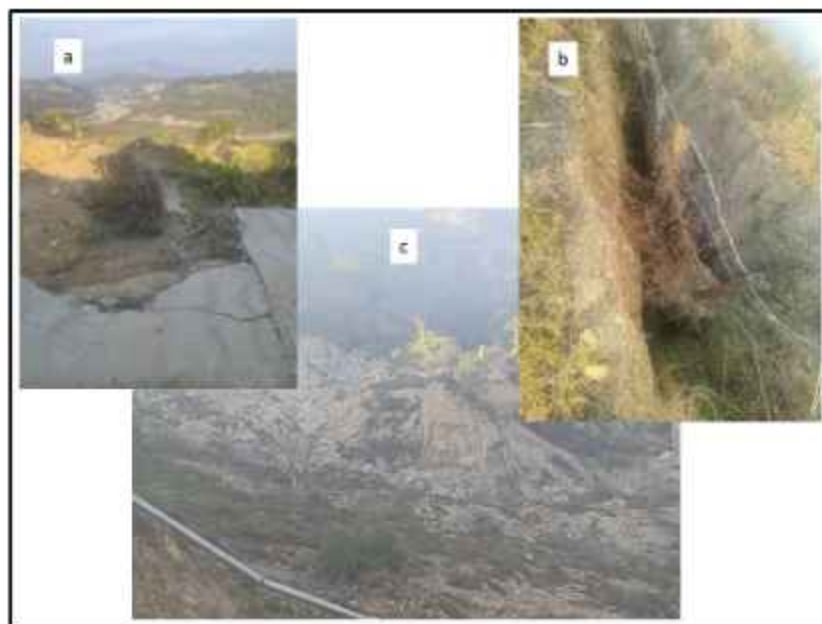
Fig. 16 a) Image depicts damage to the cemented road due to poor drainage system and b) development of wide fissure which is reminder for the next disaster. Similar features were developed on the on the displaced mass as noticed by local residents c) displaced material from the main mass and slope angle of the slide zone.

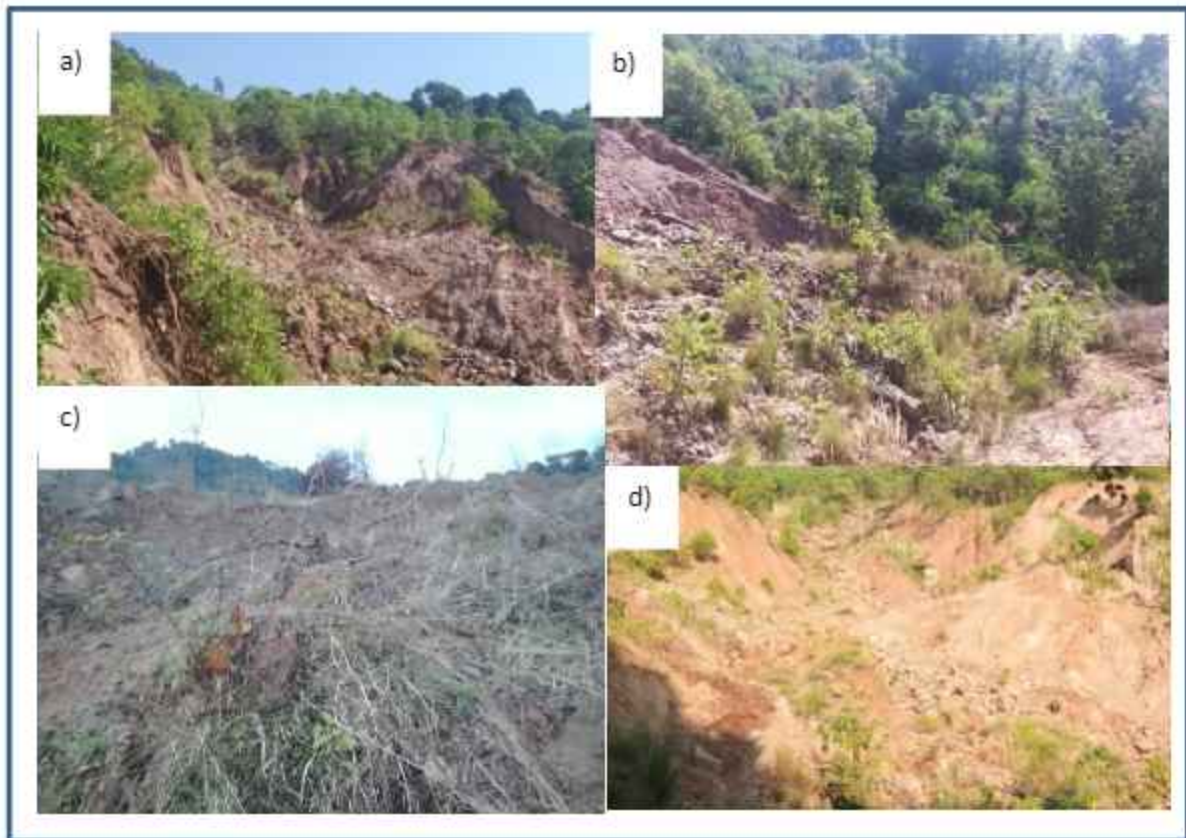
Fig. 19 Shows lithological characteristics of the slide zone: a) The area on the left of the slide zone, which was exposed due to the activity in the region; b) shows the presence of weathered rock material from the scarp region; c) the central part of the slide zones in the western side indicating weathered soil with uprooted trees and bushes, d) uneven topography on the southeast part of the slide in the slide zone with sandy to fine soil particles.

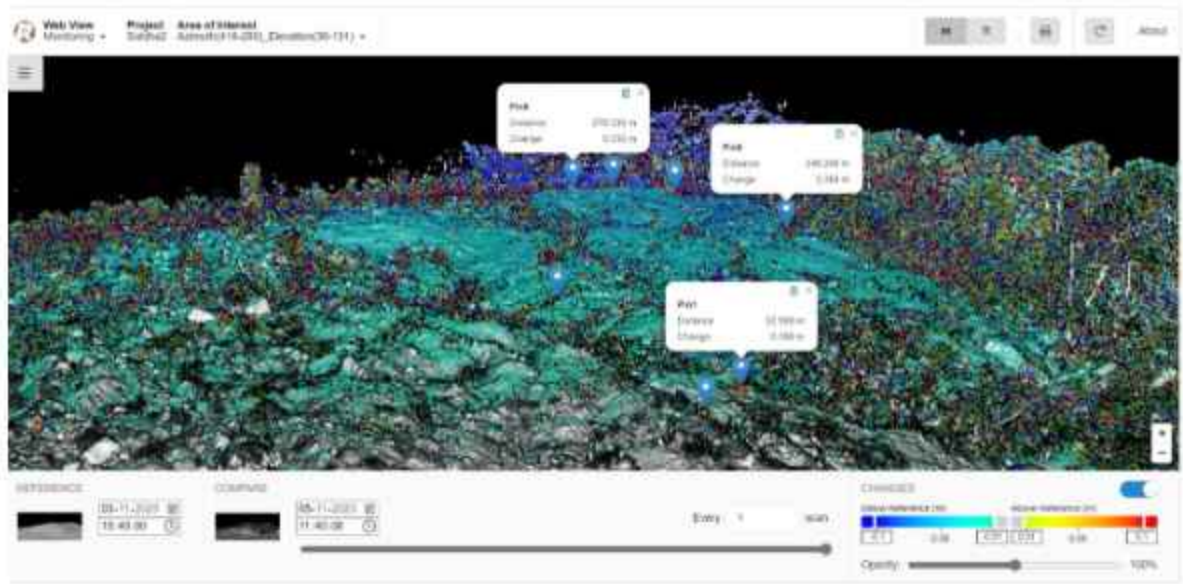
Fig. 20 Soldha (Himachal Pradesh) landslide's scan at 11:40 AM on 5th November 2023 after continuously monitoring the slide zone from 3th November, 2023. The values are highlighting the movements at various depicted places in 44 hours with respect to the reference scan. A total of 19 scans are taken. The rate of movement has been noticed which vary from 0.032m in the northwest side to 0.398 m in the south-eastern direction in 44 hrs indicating a very alarming rate of movement in the region.

Causes: Neotectonic activity, lithology of the landmass, slope angle and of course high intensity rain fall which trigger the slide.

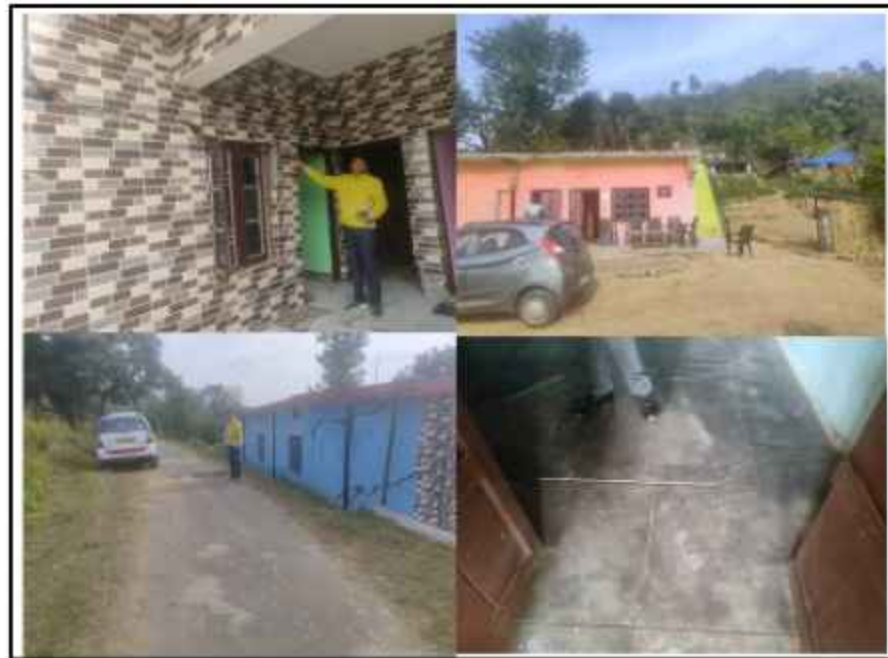
systems may help alleviate the issue in the village. The displacement observed in three to four houses within a distance of 50 meters indicates movement at the subsurface level.

Fig. 21 Shows development of cracks in the tiles and displacement of walls b) the frontal part of the houses was totally damaged and the existing one developed wide cracks in the wall indicating subsidence cracks c) Again diagonal cracks in the walls and D) floors indicating subsidence features.

- *The primary causes of the slide are neo-tectonic activity, inadequate drainage systems, and intense rainfall. Therefore, it is crucial to enhance drainage systems in the uphill region and channelize them along natural drainage paths.*
- *Detailed investigation are required for mapping the whole region in terms of tectonics and depth of slip surface using geophysical, geological and geotechnical investigations*

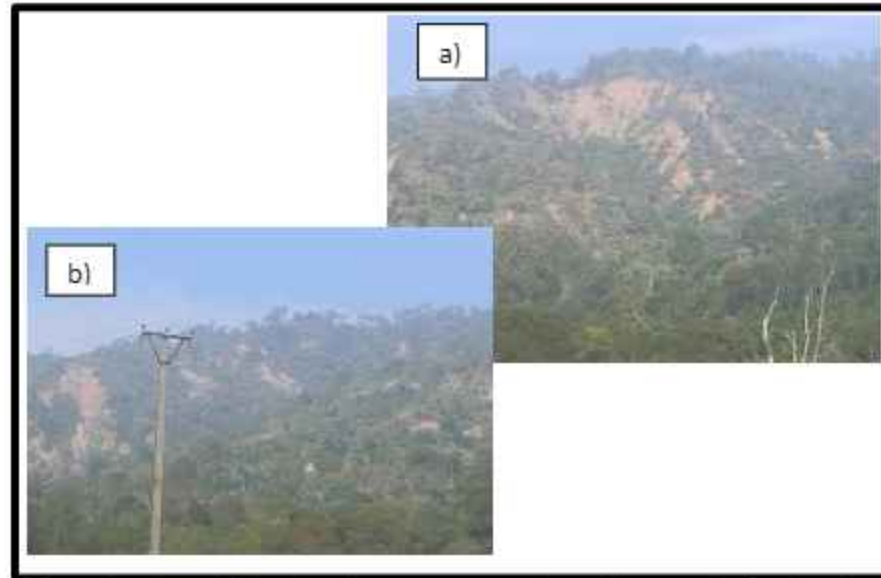
Fig. 22. Development of scars in the uphill region due to neotectonic activity north of Laduari and Jaunta villages

Causes: Neotectonic activity and poor drainage system and of course high intensity rain fall which trigger the slide, Natural drainages are blocked by construction activity.

Recommendations: Drainage system needs to be improved that will also take of high intensity rain fall to follows the natural drainages

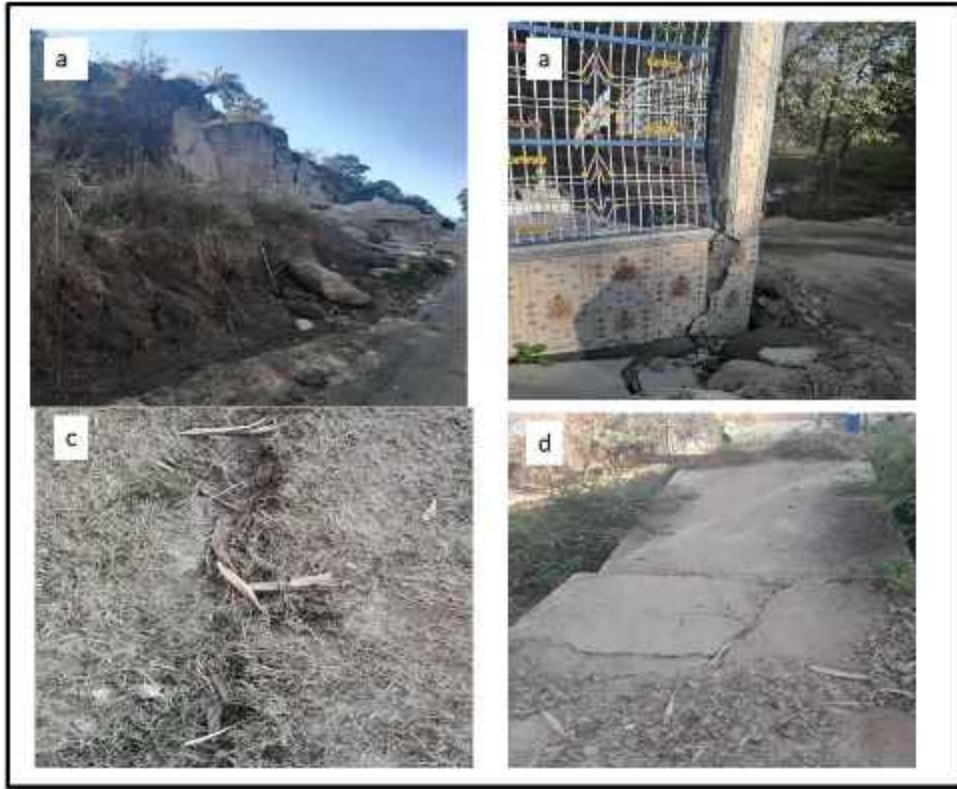
The site is situated at Latitude: 31°56'52.203'' N and Longitude: 76°19'51.630'' E in Village Dodhru. Water accumulation was observed on the northern side of the road leading to the hillock, resulting in water logging and increased pore pressures in the debris material, thus causing subsurface movement. To prevent future sliding, proper drainage is needed to alleviate the water accumulation on the backside of the hillock. Key observations of the landslide zone include. Damage to the road and temple walls, with large fissures formed throughout the structure (Fig. 23). Settlements behind these structures also experienced cracking, with gaps of 4 to 5 cm appearing between them

Fig. 23 Images showing hillock of the Middle Siwalik rock behind which the water was logged during heavy rain fall b) showing the damage caused to the temple due to subsurface movement. Land fissure developed in agricultural land downstream d) damage of cemented path leading to houses.

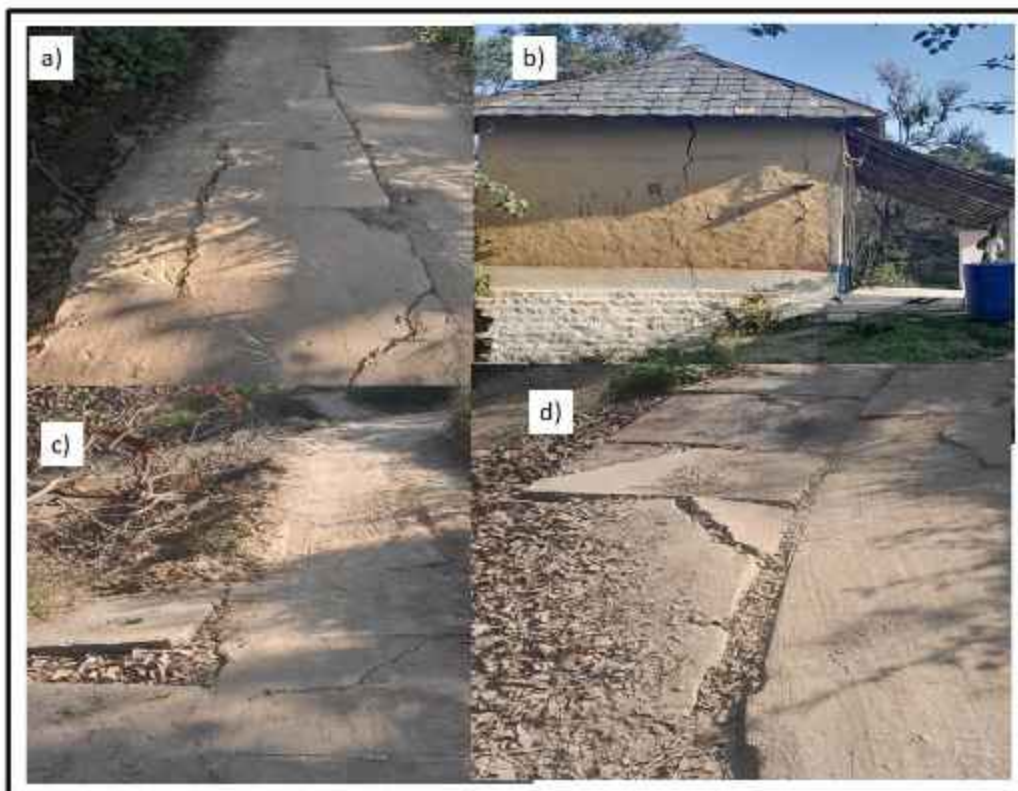
Fig: 24 Images showing damage of road leading to Mard village and development of cracks in walls of mud house, but house was not affected by the movement of the landmass because the major effect of movement was on eastern side.

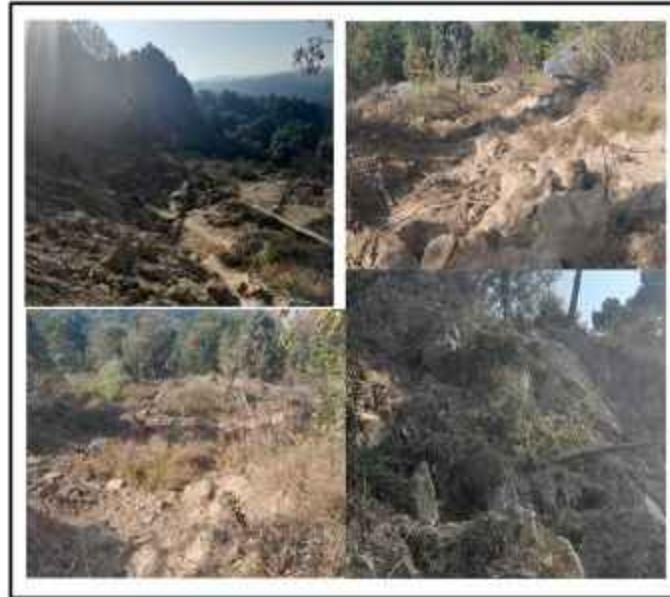
Fig.25. Shows the damage in lower Mard village hillock due to high intensity rainfall, uneven topography, uprooting of tree and developed of crevasses and depression indicated the pressure of rain fall on 14th August 2023.

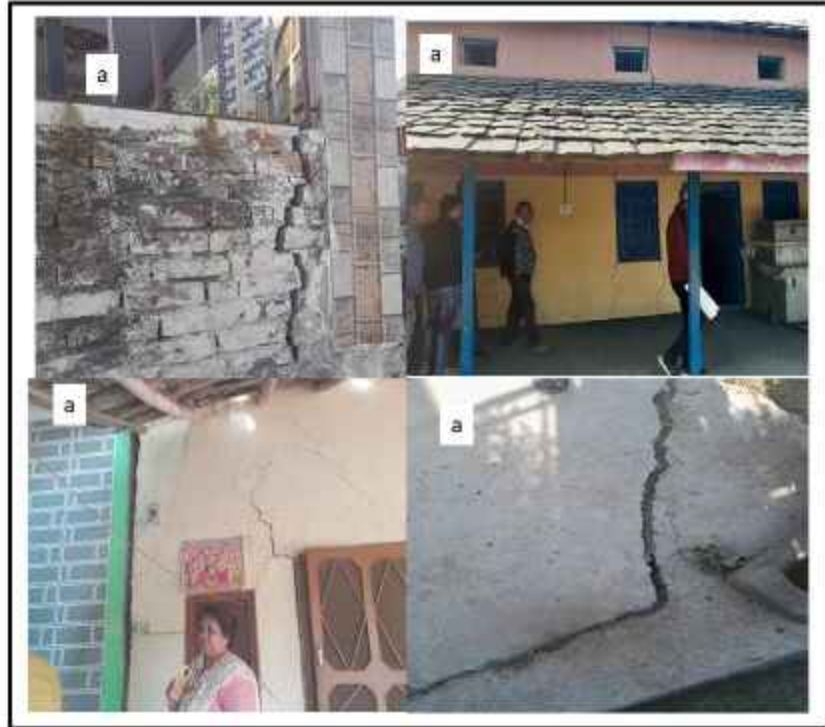
Fig.26. Shows subsidence crack in walls, and roads due to water logging and poor drainage system in the village. No doubt high intensity rainfall contributed to the damage but the moisture already present in the soil got accelerated by high intensity rainfall and thus developed subsidence crack at Pokhru village.

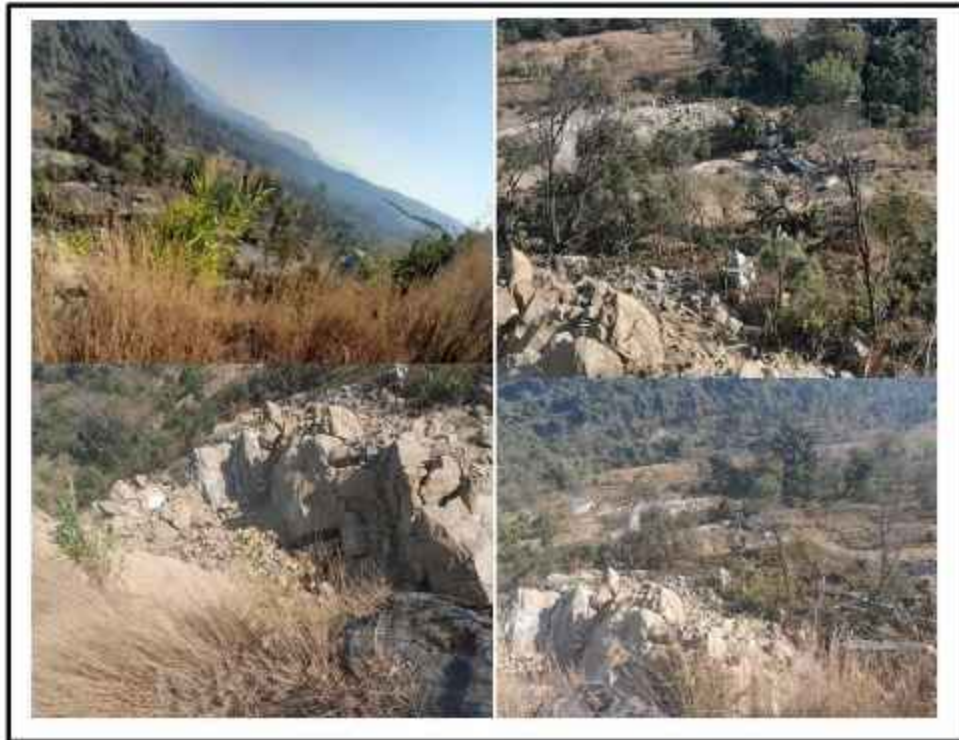
Fig.27 Shows displacement of rock chunks from the main mass (Middle Siwalik Sheet rock) uphill and caused damage to the village located lower side.

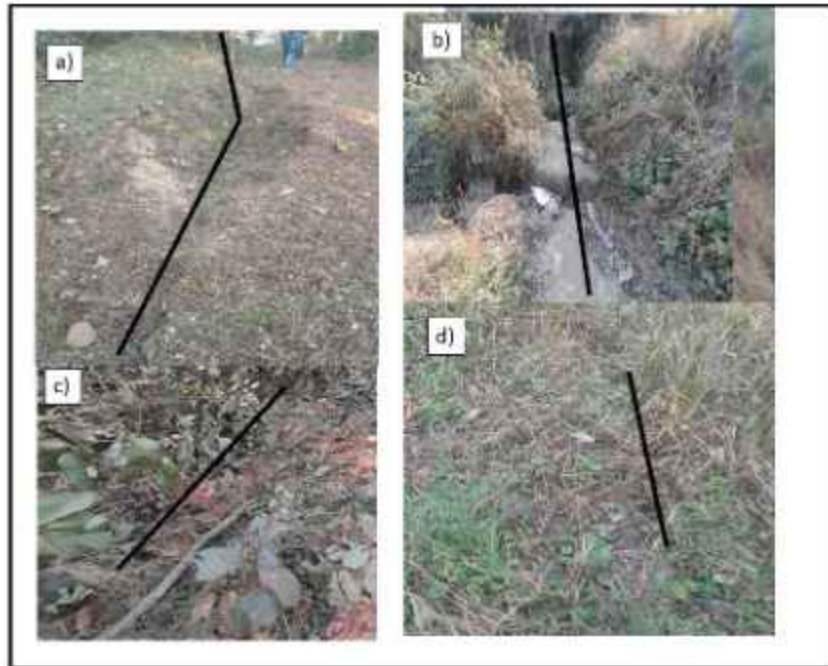
Fig.28 a, c) Shows the development of land fissure and its direction at the summit of the landslide zone Images b) indicated the natural drainage present in the same summit zone by running along the slope direction. d) Again showing the direction of the fissure developed in the upper part of the slide zone.

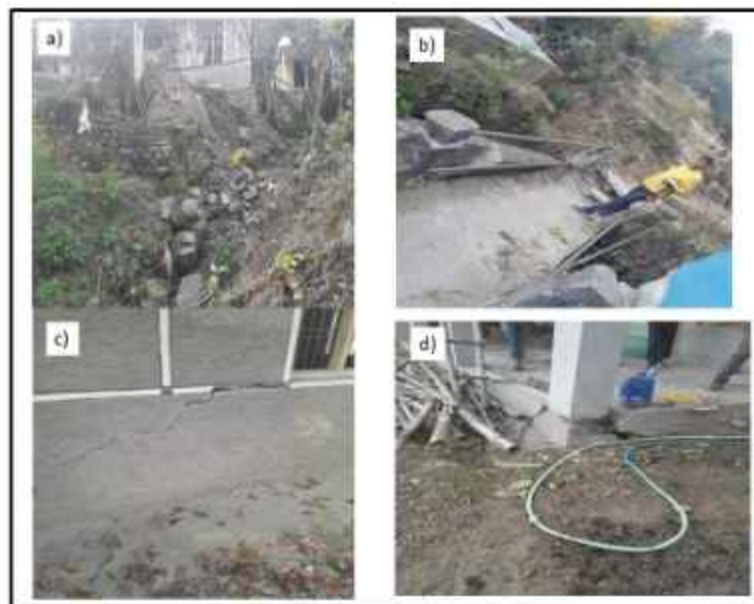
Fig. 29: Shows damage cause in the middle part of the slide zone to housing and erosion of the retaining walls along the natural drainage b) damage of cemented path c) development of cracks in building d) displacement of pillar and damage caused.

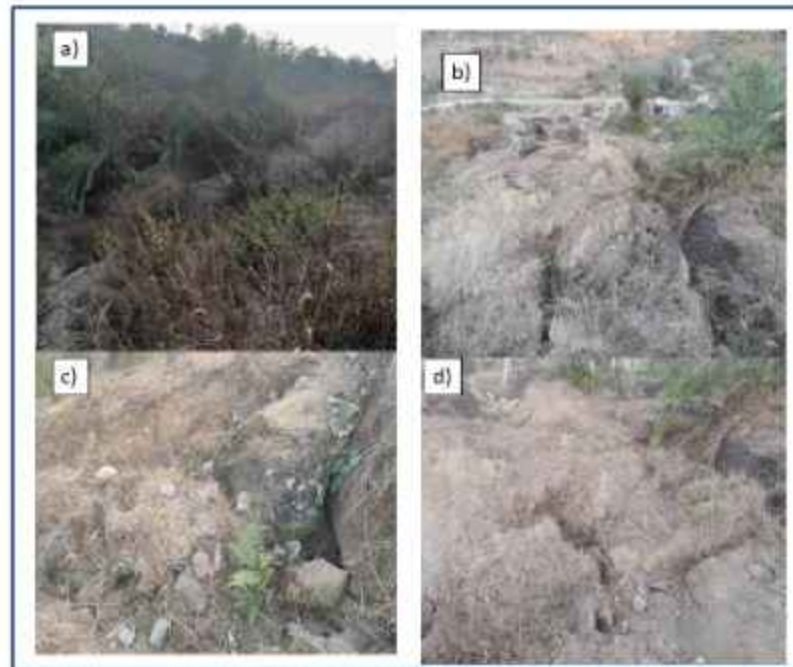
Fig.30. Shows the uneven topography in the lower Ambada (toe region) a) uprooting of tree and bushes b) developed of crevasses and cracks c) uneven topography and d) developed of cracks and movement of landmass downward.

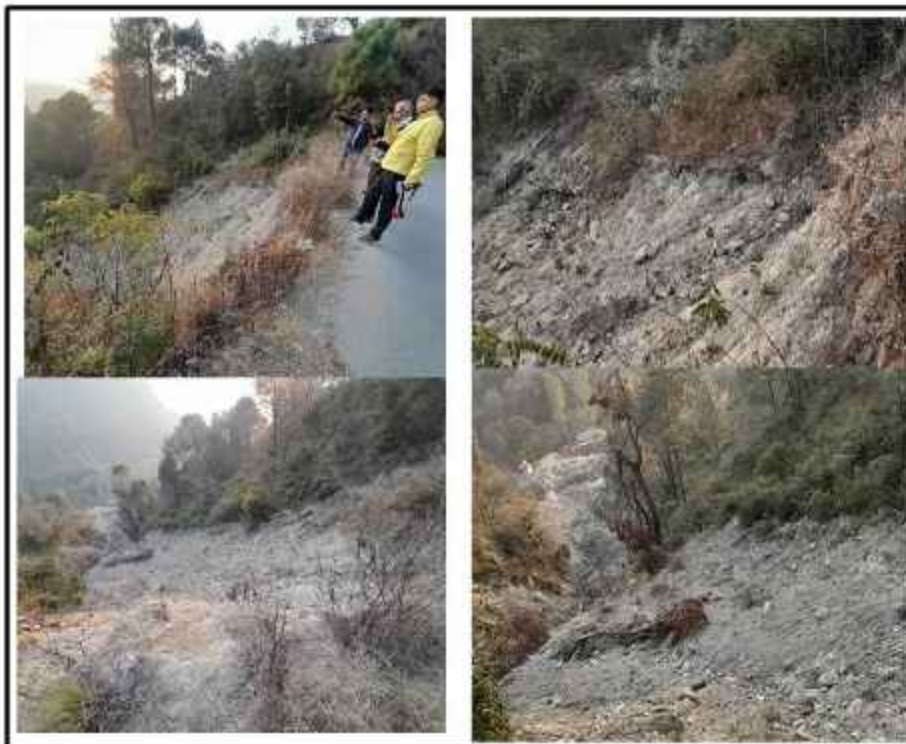
Fig.31 a) shows the upper portion of the slide from where the sliding starts along the road side b) middle part of the slide zones c) indicated the uprooting of tree and extent of flash flood d) the lower part of the slide zone which joins the river downstream.

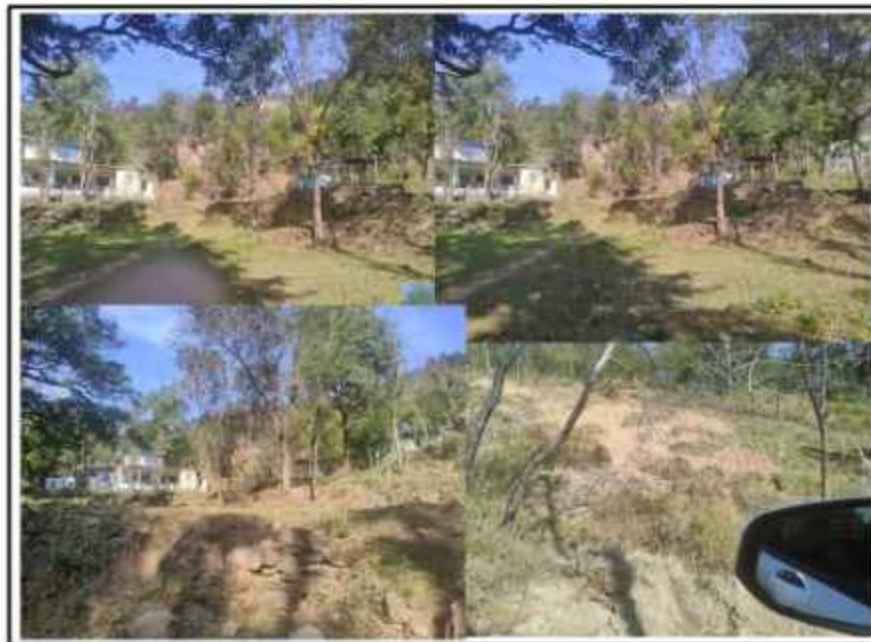
Fig. 32 Image depicts the scenario of village Anain where there is no land fissure have developed however, a scar has been developed on back of these houses.

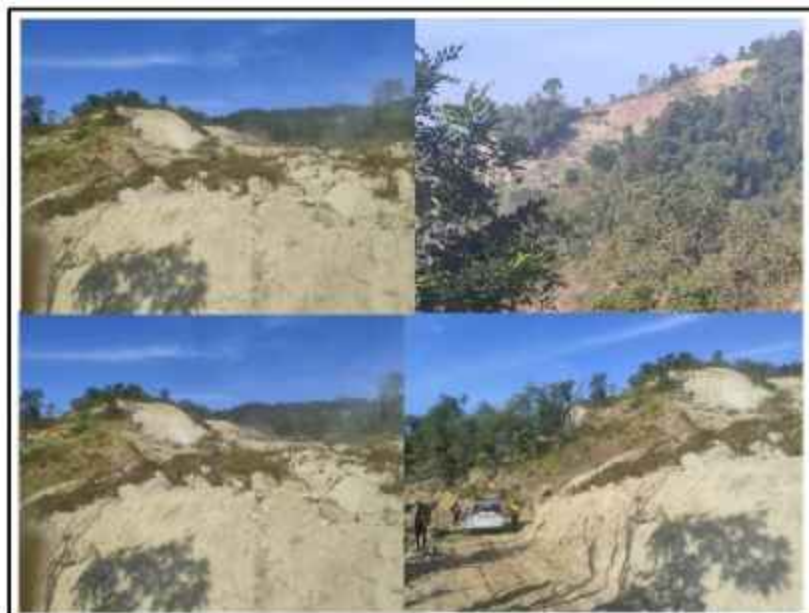
Fig. 33 Image depicts the immature topography of the road leading to Anain village.
