PRELIMINARY INVESTIGATIONS OF LANDSLIDES ZONES IN KANGRA AND CHAMBA REGION AS PER NOTIFICATION NO REV (DMC) (F) 11-09/2021- LM DEPARTMENT OF REVENUE (DM CELL), GOVT OF HIMACHAL PRADESH.

PROF. AMBRISH KUMAR MAHAJAN

CENTRAL UNIVERSITY OF HIMACHAL PRADESH

DATE: 26TH February 2024

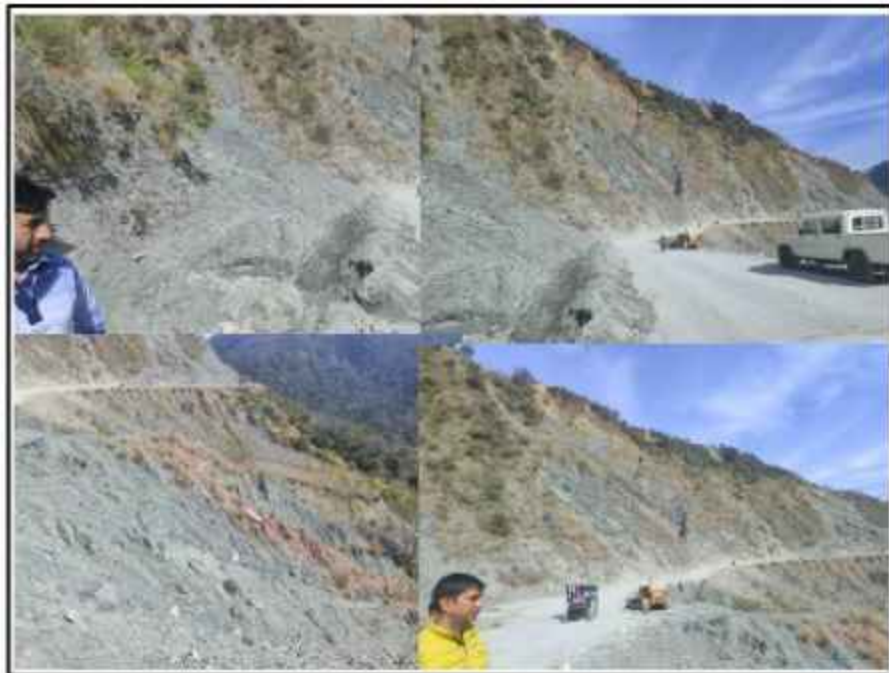
Fig.34. Image depicts the Kali dhar slide zones with pulverised material of volcanic rock and phyllites. When mixed with water it loses its frictional strength and moved like slurry along slopes. Even the material from hillock moves down. The slide is in the thrust zone and not easy to mitigate the activity however bioengineering measure may reduce the soil erosion.

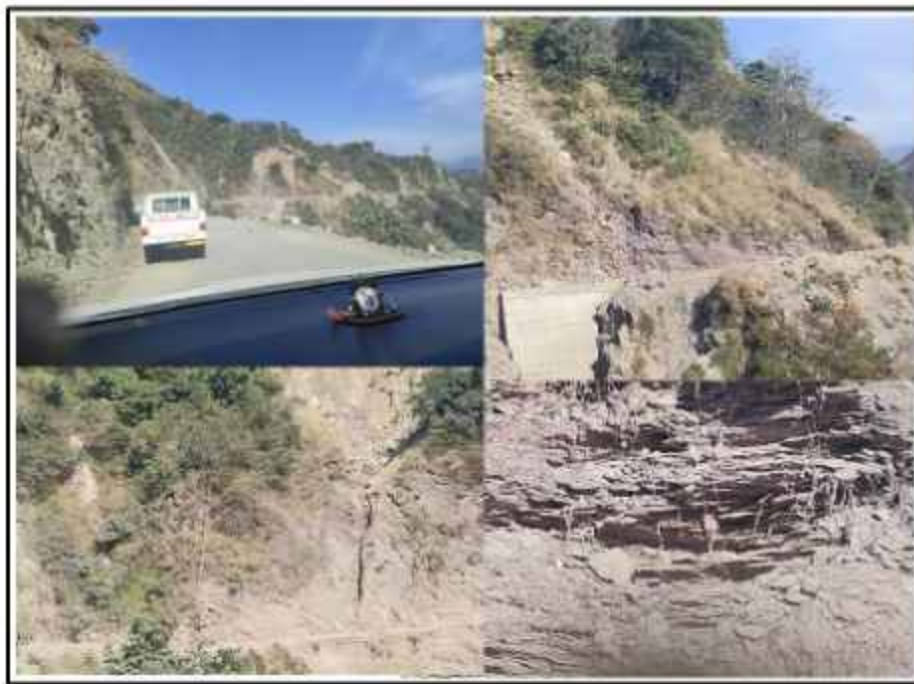
Fig.35 Image depicts the sheared carbonaceous shale and phyllites at Brahmpala site which indicated that they are under stresses due to their location close to the MBT and Panjal Thrust.

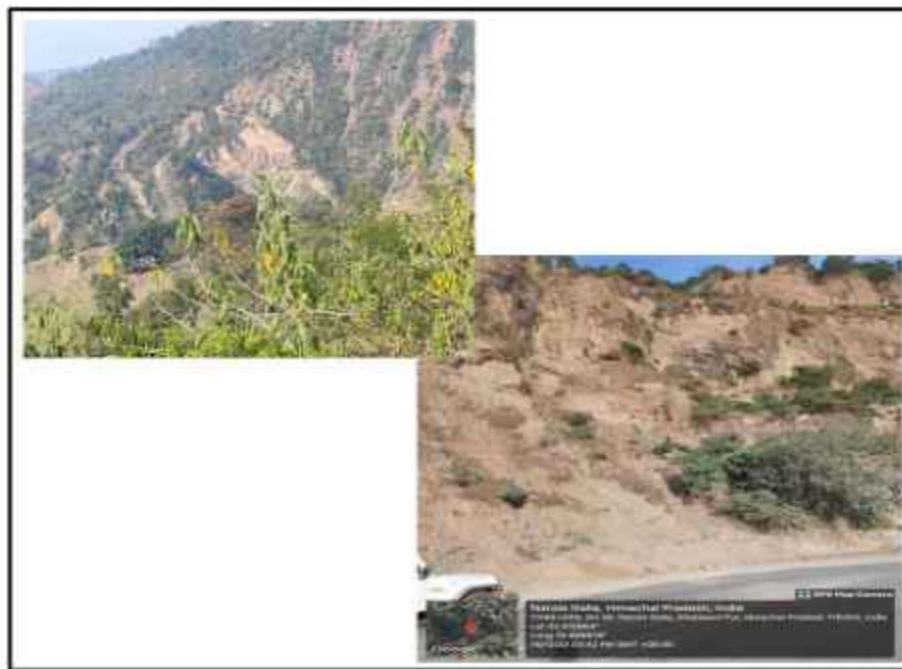
Fig.36 Image shows the rock type (sandy rock intercalated with pebbles layers. The site is under denudation which resulted weathering of pebbles layer.

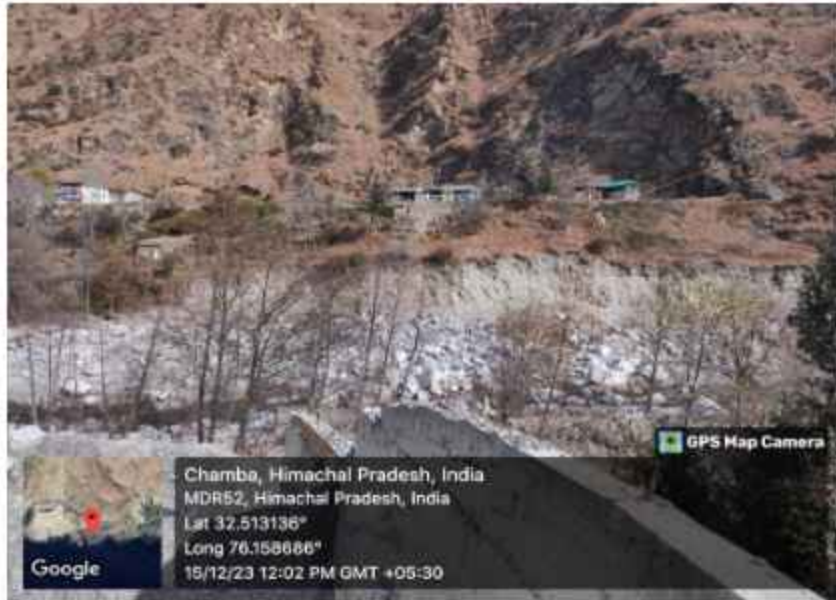
Fig.40 Image depicts river erosion at Village Saloon long Holi road.

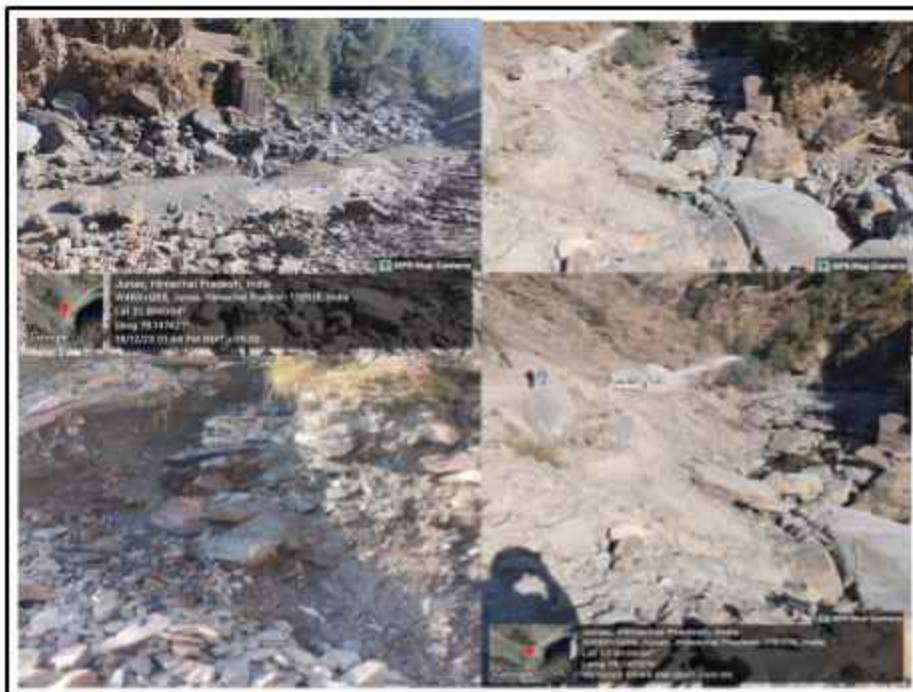
Fig. 41 a) Images depicts the erosion of sediments and cutting of hillock on left side of the river Ravi opposite Jhadouta Ghar village toward main road. B) the Village located on the right bank of the river also get affected and needs protection c) river cutting due to river course diversion during high flood level d) Right bank of river indicating erosion of sediments and road subsidence at Kuther. Further, the subsidence of road and erosion of land was due to river cutting and slope angle. The slope angle needs geometrical modification and the hillslope needs to be protected from toe erosion by erecting gabion barrier to protect the hillock from direct touch with Ravi river water structures and erection of concrete from deeper depth at the toe and gabion structure from middle of the slope will protect the slope from further degradation

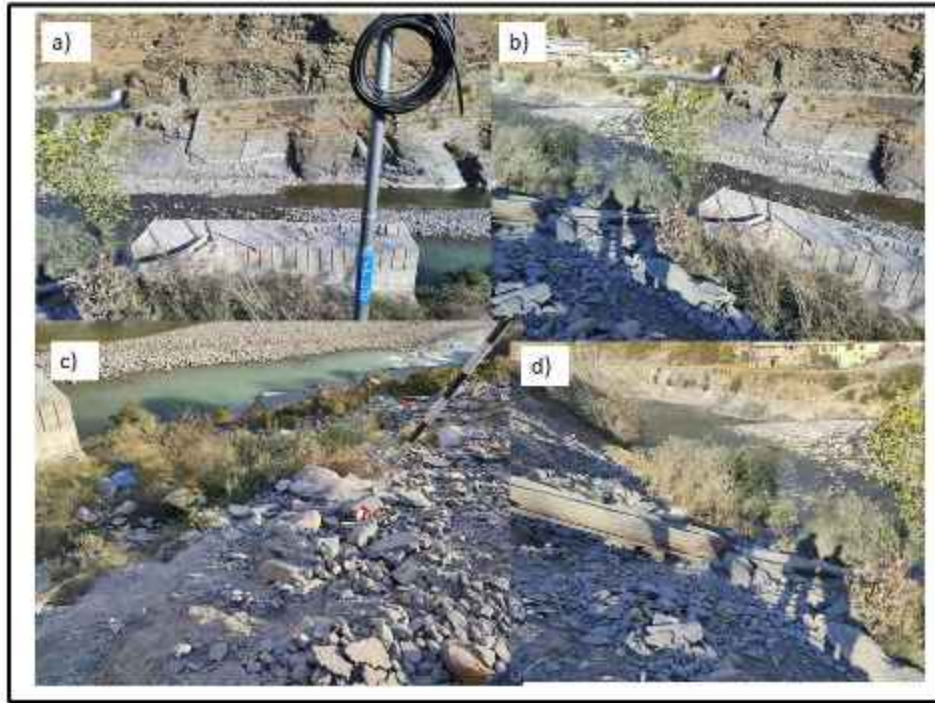
Fig. 42 Image depicts a) damaged retaining wall raised within the water body due to subsidence of the foot of the wall b) Damage to the retaining wall on right bank of the river c and d) area river and road indicating enough space for raising protections walls.

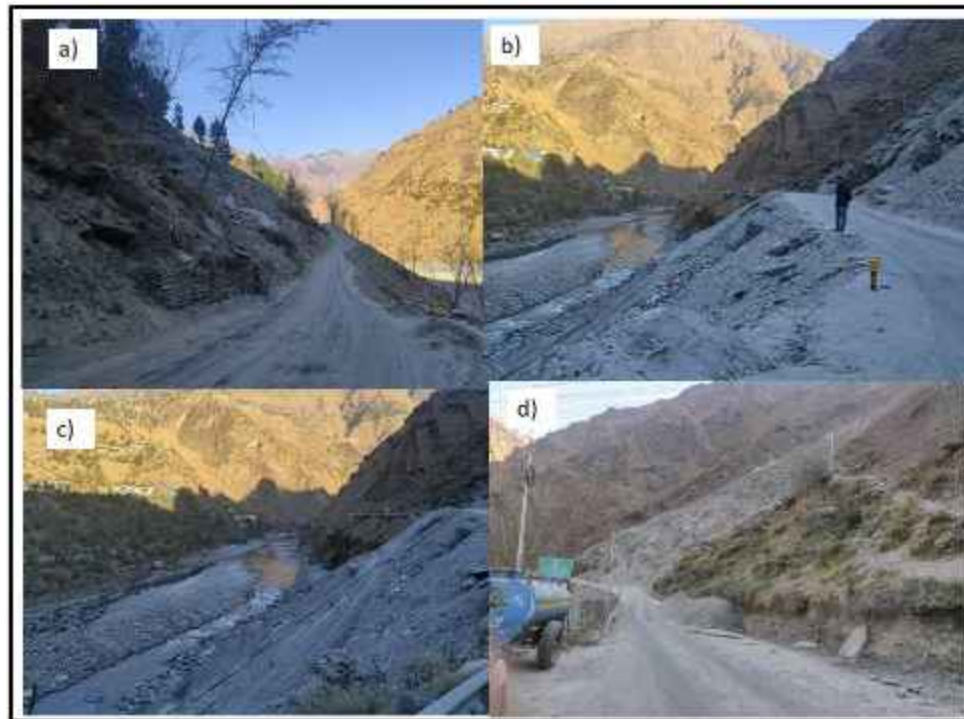
Fig.43: Lothal slide zone where presence of shear zone slope angle and water scoring action leads to toe erosion and further movement of the hill slopes and cause damage to the road.

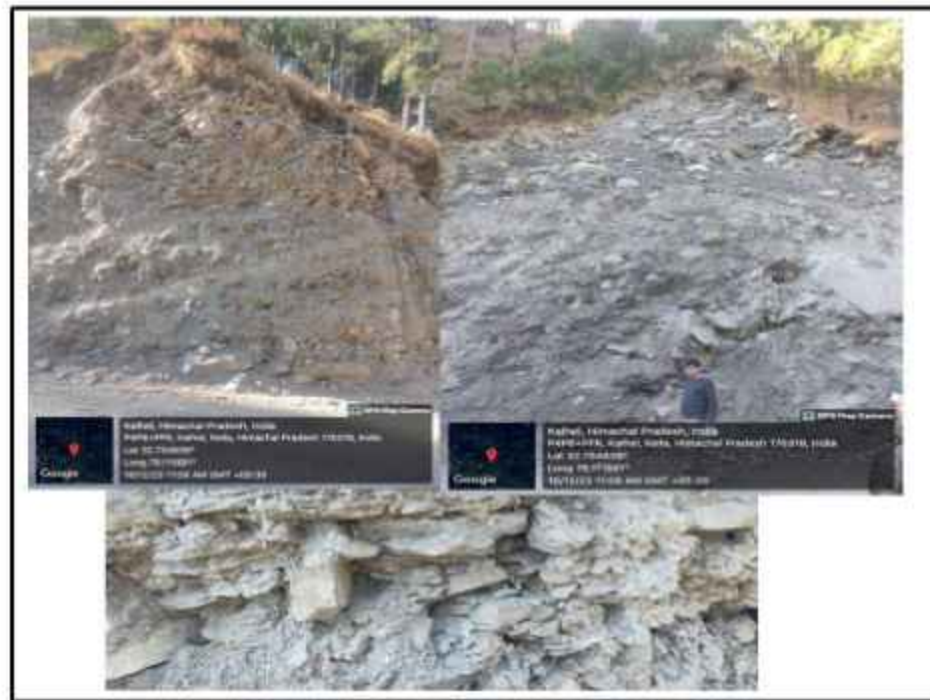
Fig.45 Image depicts a) highly shattered phyllites rocks with number of joint planes which are subjected to high stress due to presence of tectonic plane in its vicinity b) shows the upper reaches of the MDR 85 sites with very loose material which can move downslopes under high moisture condition due to its low frictional strength c) Phyllites rocks with number of joints and sheared adjacent to the MDR 85 site.

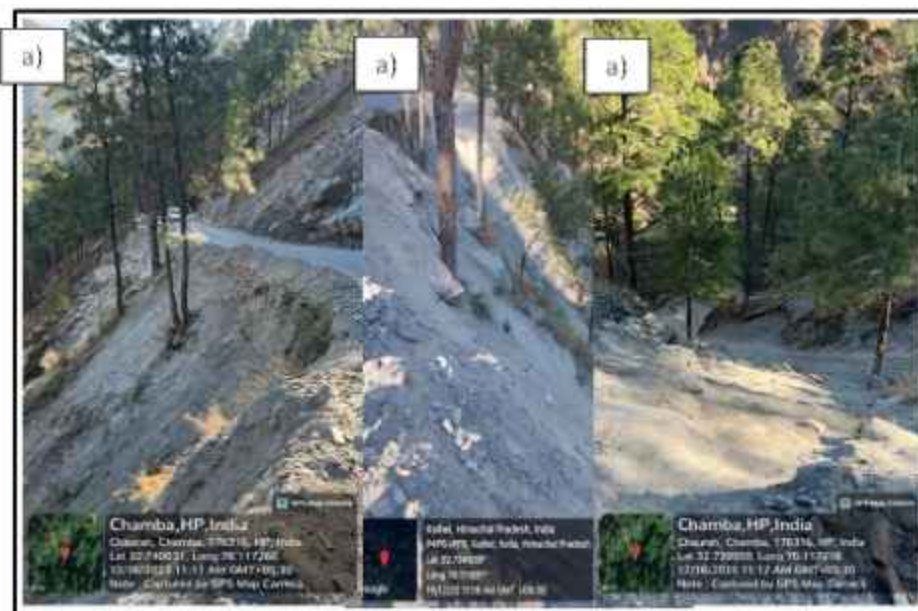
Fig.46: Image depicts a) leeward side of the road where hard rock dipping towards hillock can be seen which can be used to raise the protection and road widening wall b) slope angle and the pulverized material located at MDR 85 site c) the slope angle at the lower part of the slide zone

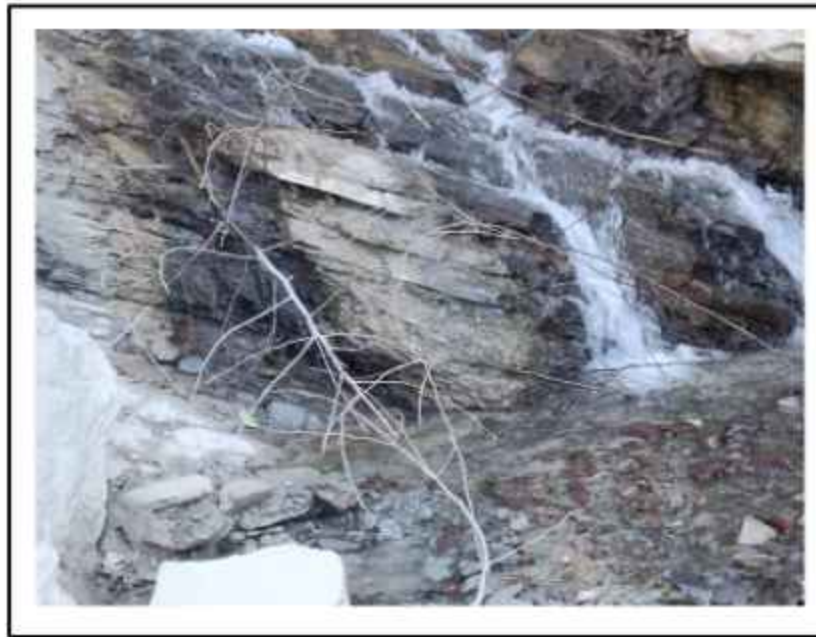
Fig.47 Image depicts the phyllites rocks present along Pangola nala and jointn direction which are oriented towards the road side which brought the tackles towards road. Raising protection wall and ejecting cementing material will protect the slide zone.

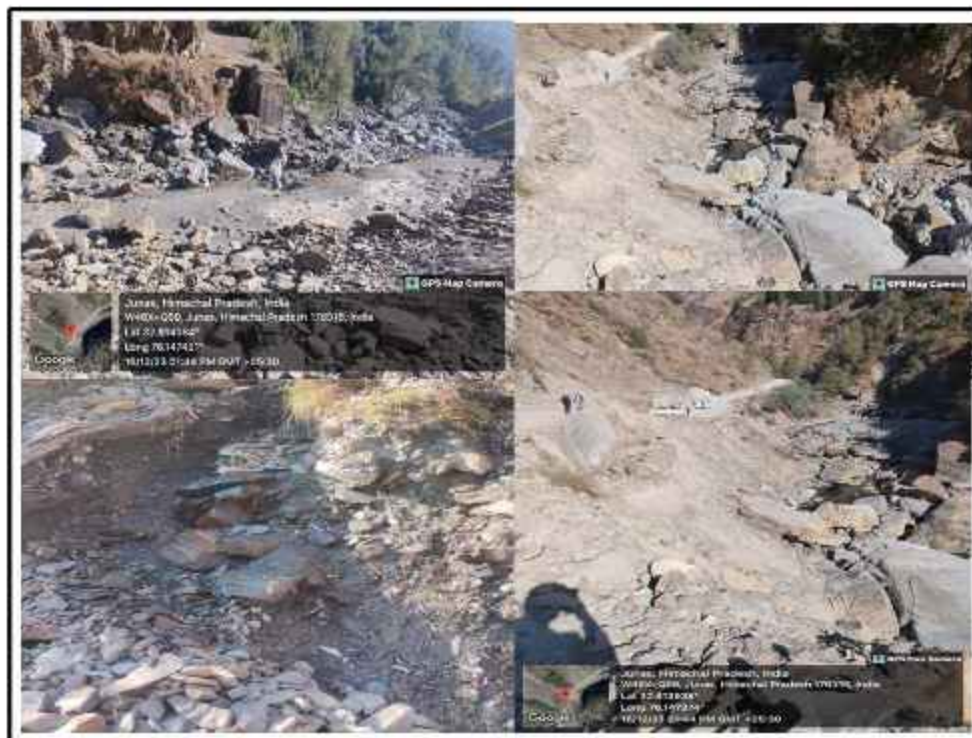
Fig.48 a) Shows the damaged part of the road and retaining wall along the Tarela-Boundary Mangli Road slide zones b & d) indicated large chunk of slates and boulders which can be used to diver the river channel and slope angle of the slide zone c) shows the moisture content and irregular stones which have been broken from the in situ rock.

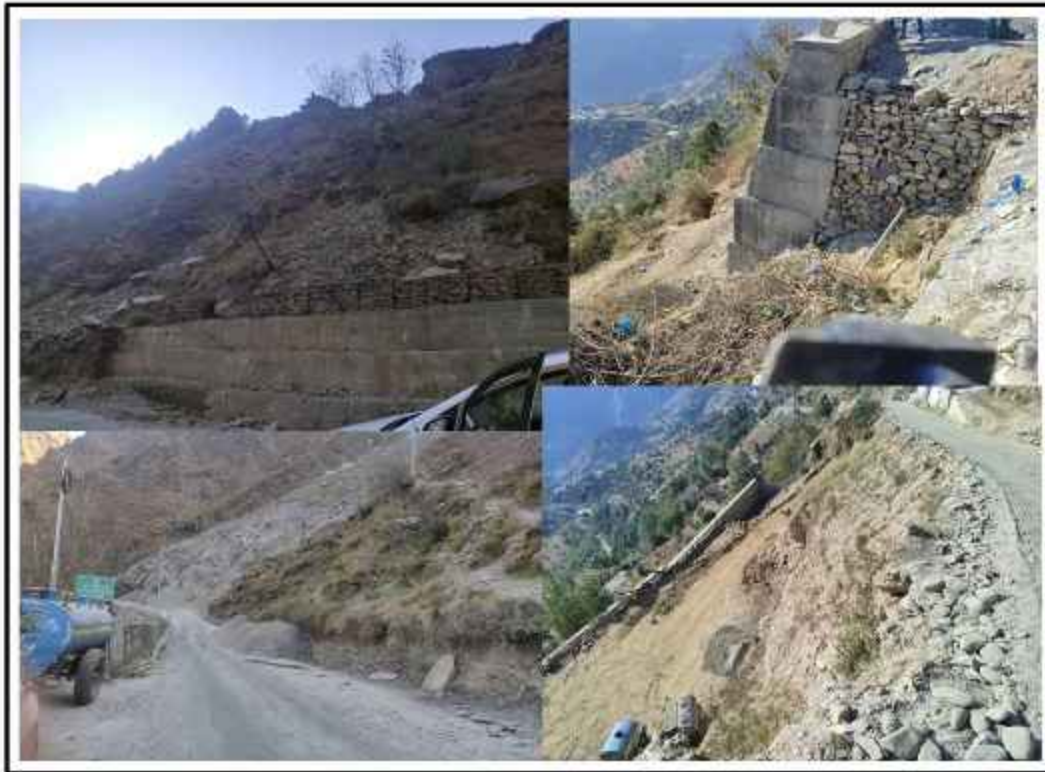
Fig.49. The image illustrates the following features: a) The slide zones along the road are predominantly composed of rock fragments, primarily consisting of lesser Himalayan Phyllites and slates b) A substantial retaining wall has been installed at the crest of the slide zones. However, this wall increases the load at the crest, potentially inducing downslope movement of the land mass over time. This is attributed to the expected rise in pore pressure within the land mass c) The designated site for the proposed hospital construction can be observed d) The slope angle at the proposed sites, along with rock fragments and debris material, presents a significant risk to the proposed building, especially during periods of high-intensity rainfall, potentially resulting in disastrous consequences downstream

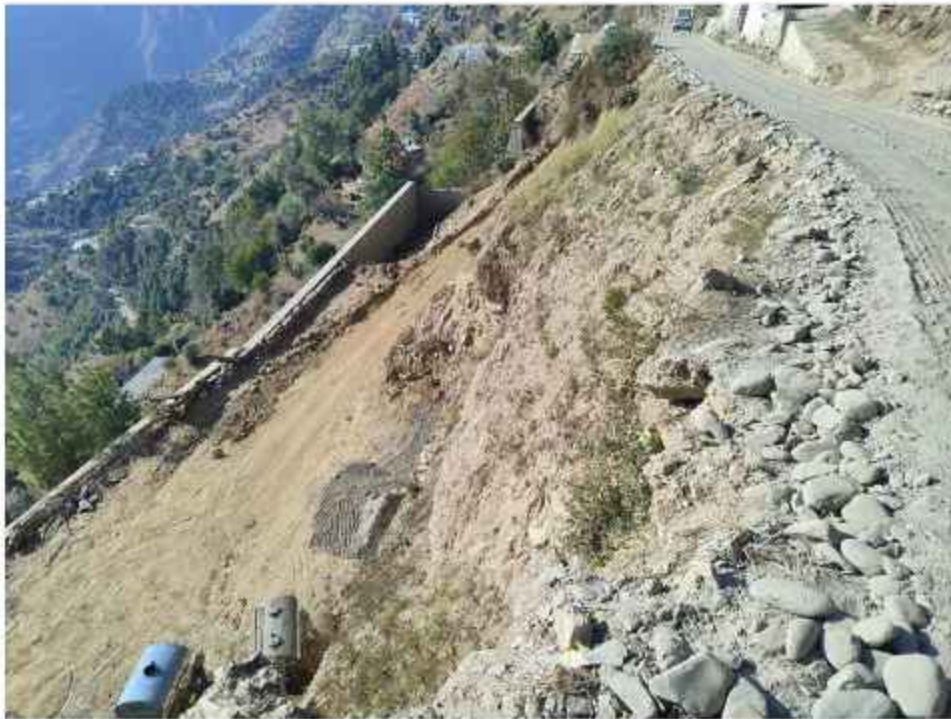
Fig.50. The image depicts the slope angles and reclaimed land intended for the proposed hospital site in Salooni Village. However, it is evident that the heavy concrete wall constructed on the steep slope may not endure over time due to its weight and the nature of the slope material. Moreover, the design of the retaining wall is flawed, as it has the potential to exacerbate pore pressure in the area. This could lead to destabilization, particularly during periods of high-intensity rainfall or continuous rain events. Consequently, it is concluded that the site is unsuitable for accommodating any large structures, including a hospital
