PREPARATION OF LANDSLIDE HAZARD ZONATION
MAP OF DHARAMSALA TOWN AND ADJOINING AREA,
DISTRICT KANGRA (H.P.)

Title of Project: **PREPARATION OF LANDSLIDE HAZARD
ZONATION MAP OF DHARAMSALA TOWN &
ADJOINING AREA, DISTRICT KANGRA (H.P.)**

Report Period : March, 1999 to March, 2000

Name of Investigators : Dr. A.K. Mahajan
Dr. N.S. Virdi

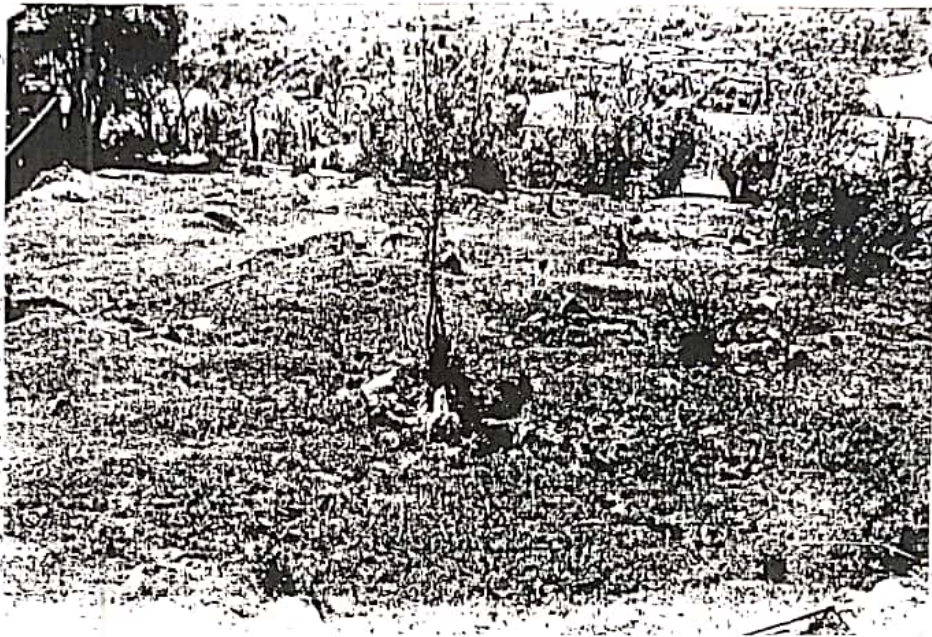
Fig. 10: Swampy land area in Tikka Gamru

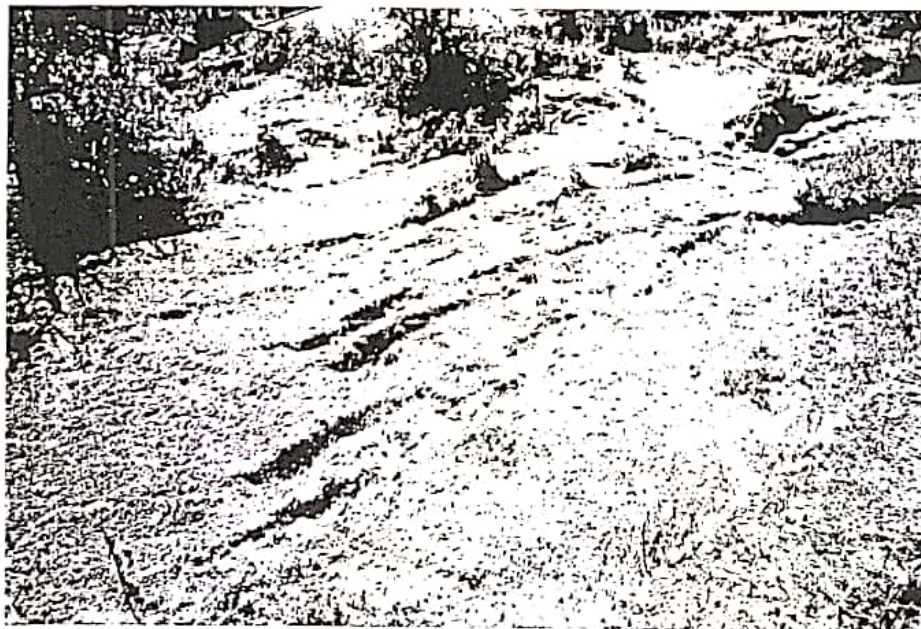
Fig. 11: Development of transverse cracks on slopes in Tikka Gamru

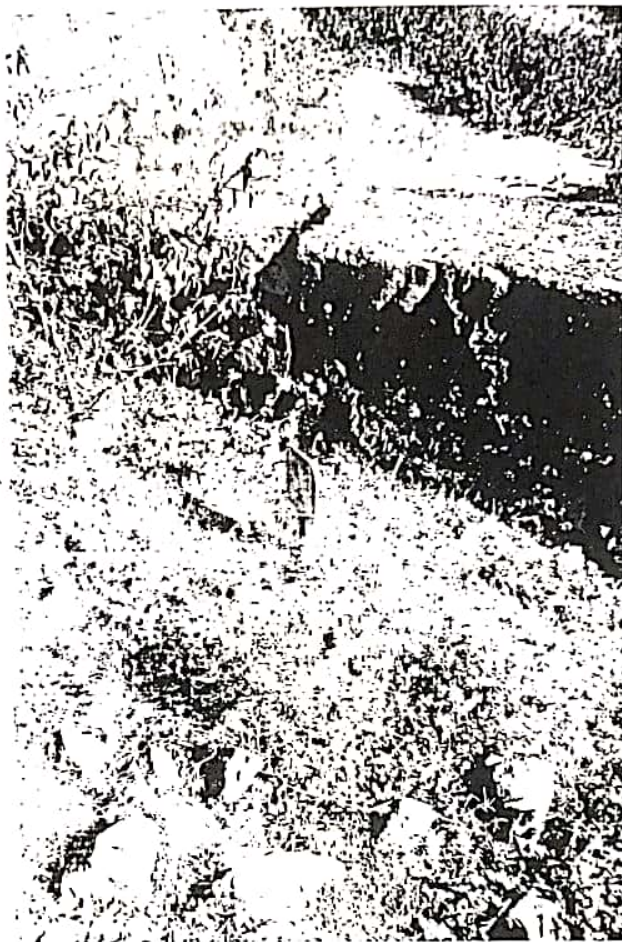
Fig. 12: Distress in foundation walls due to slope movement Tikka Gamru

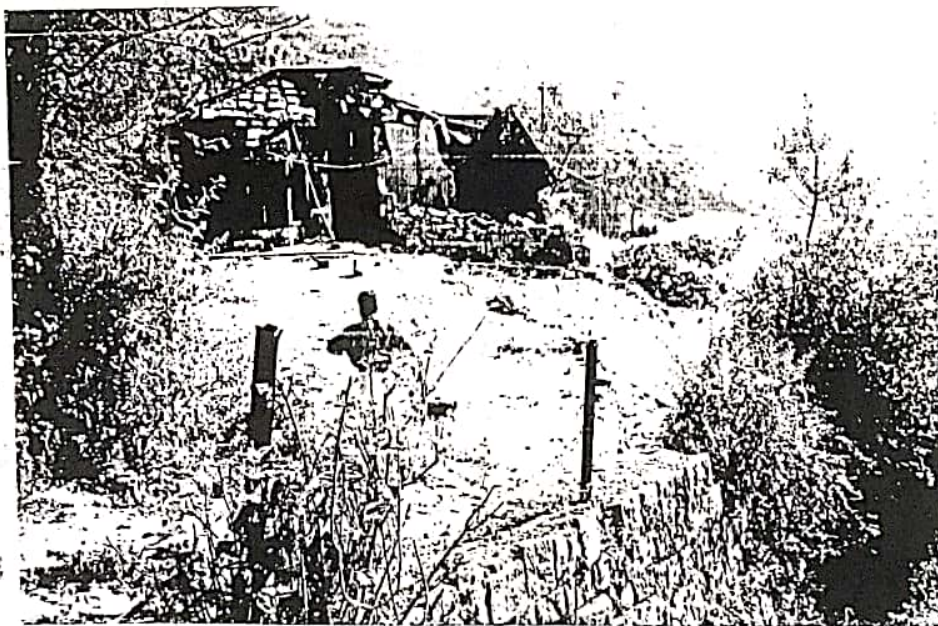
Fig. 13: Building damaged by landsliding in Tikka Gamru

water and thus leads to solifluction and creep movement in the area. Some of the recent and old constructions shows clear evidences of movements. There is an urgent need to clean up all natural drains; control septic tank disposal and channelise waste water disposal from the Tibetan complex and resident of Gamru, not only to save Tikka Gamru area but also Ram Nagar and Shyam Nagar

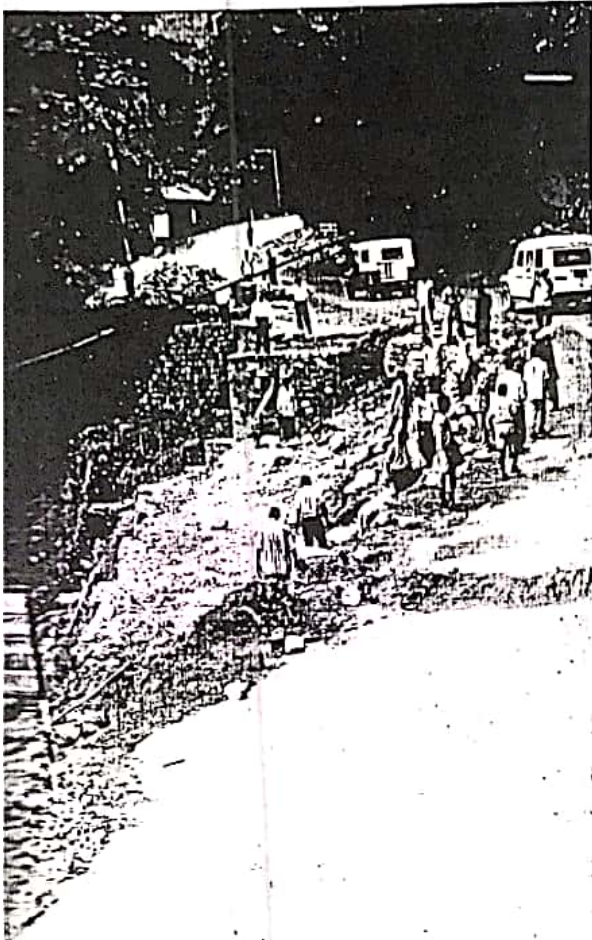
Fig. 14: Road subsidence (3-4 m) in DCR slide zone

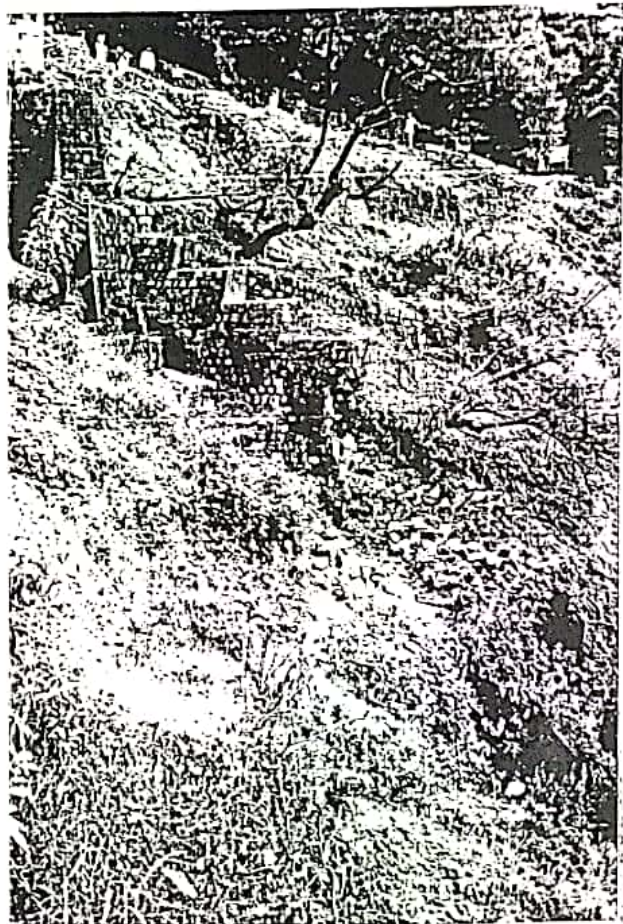
Fig. 15: Tilting , uprooting of trees & bulging of walls in DCR slide zone.

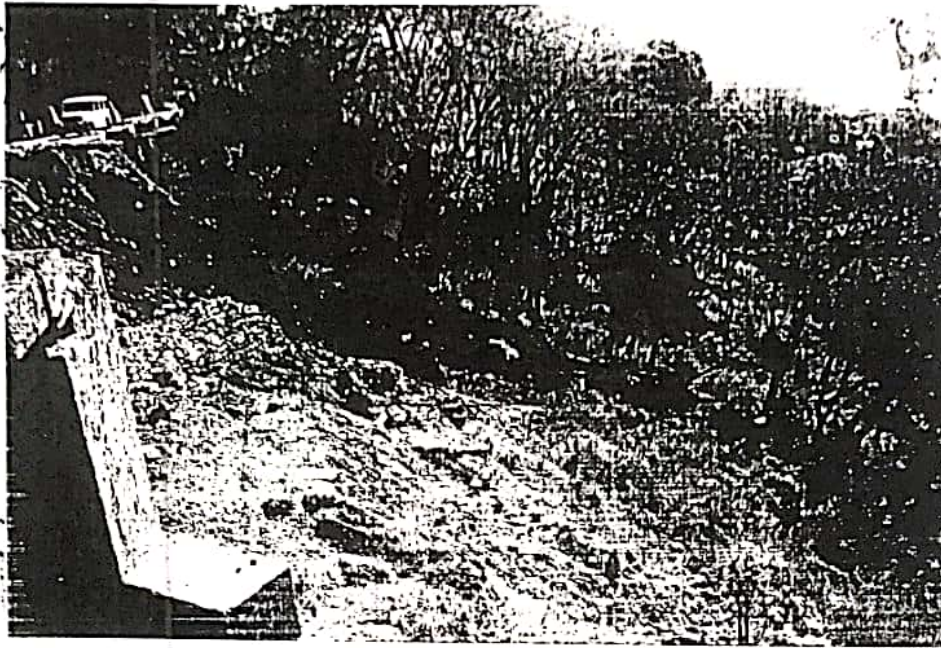
Fig. 16: Impact of Overloading at crown level - Failure of old retaining wall in DCR slide zone

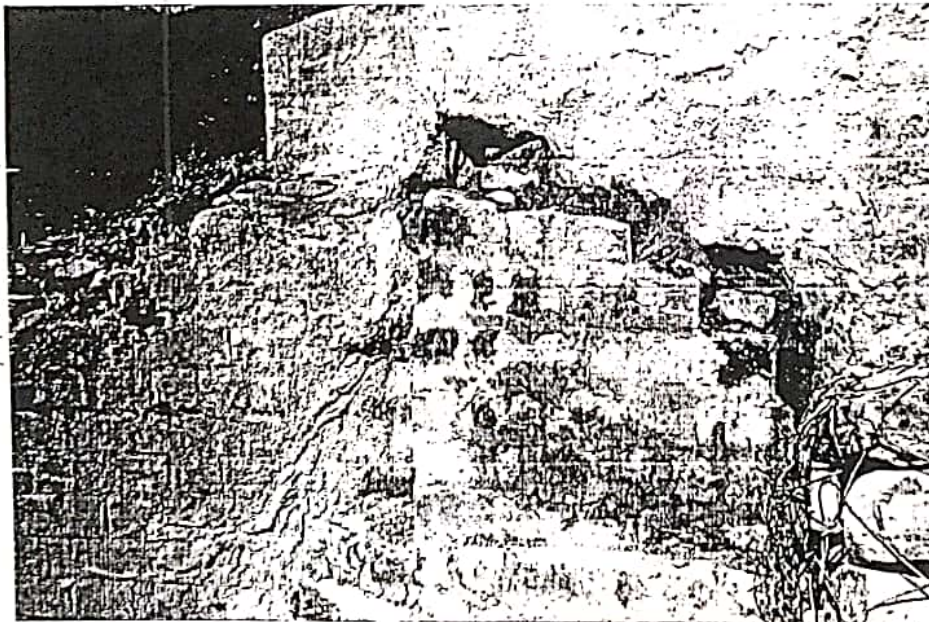
Fig. 17: Subsidence in support walls of a road bridge due to sliding activity in DCR slide zone

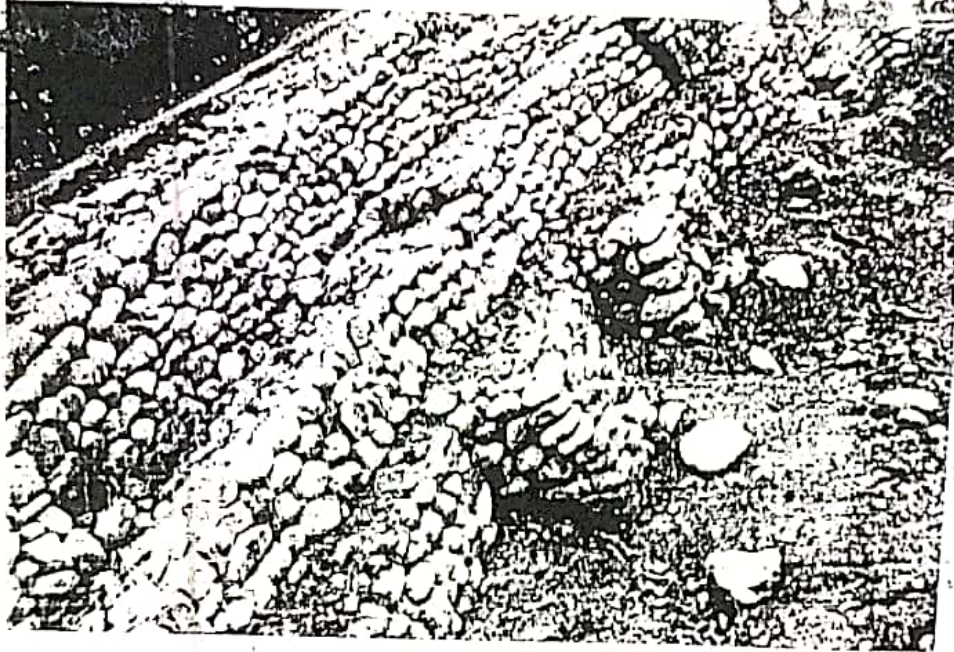
Fig. 18: Improper overloading at crown level to control landslide in DCR slide zone

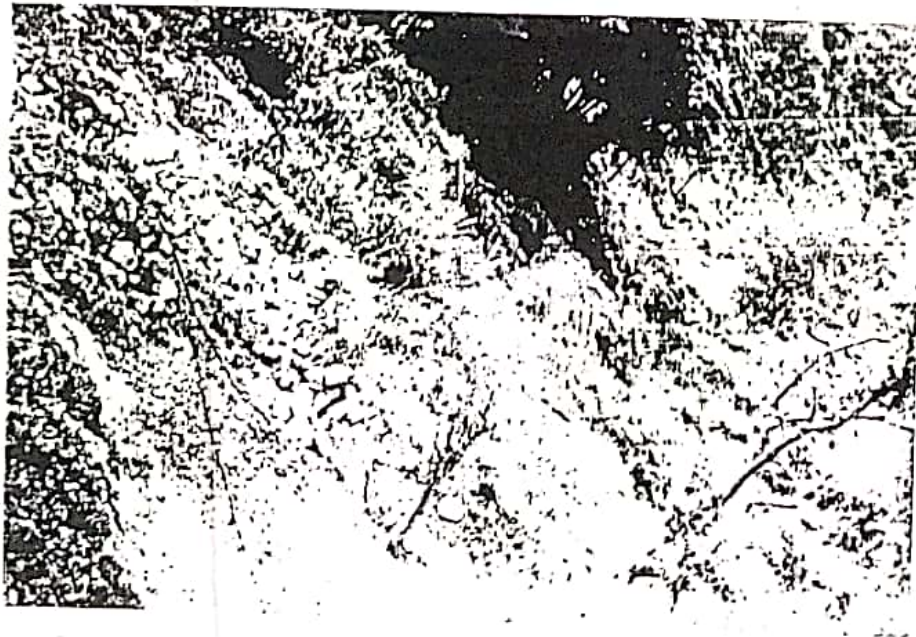
Fig. 19: Uprooting of trees, loss of vegetation and failure of wire crated stone wall in DCR slide zone

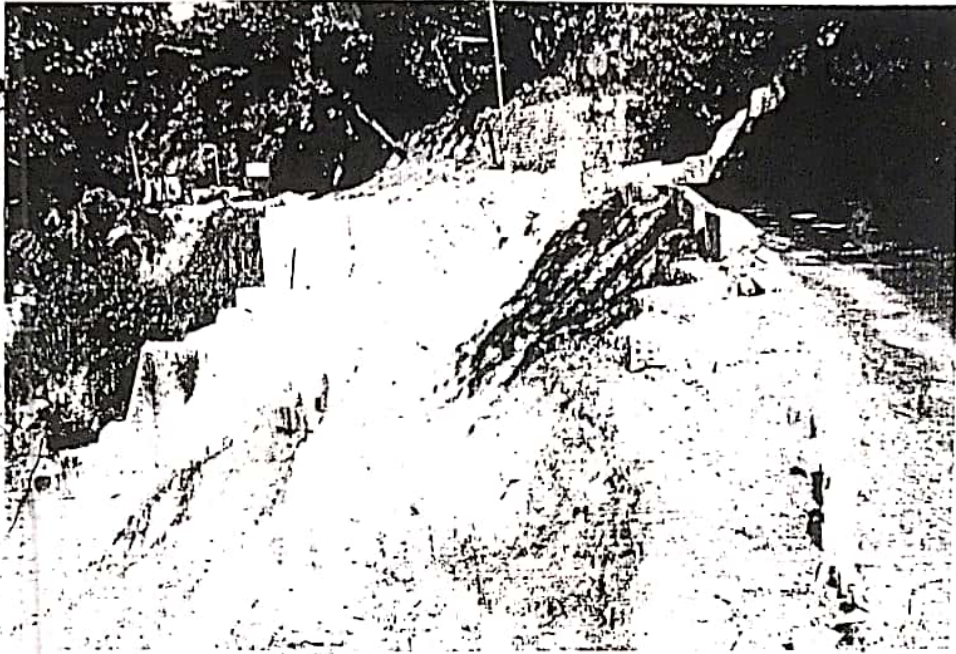
Fig. 20: Overloading of crown zone causing damage to road in DCR slide zone

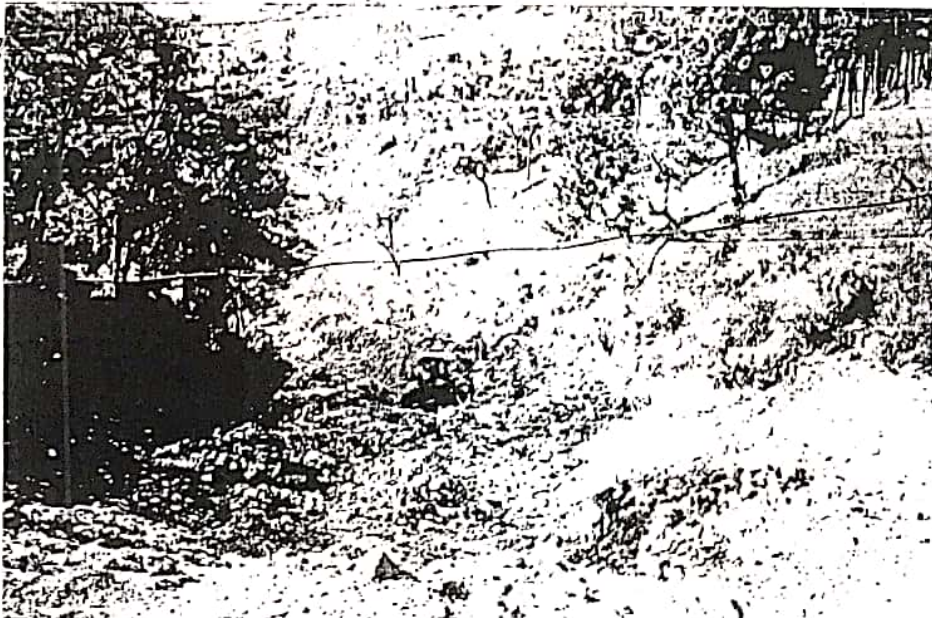
Fig. 21: Development of transverse cracks and damage to lifelines in DCR Slide zone

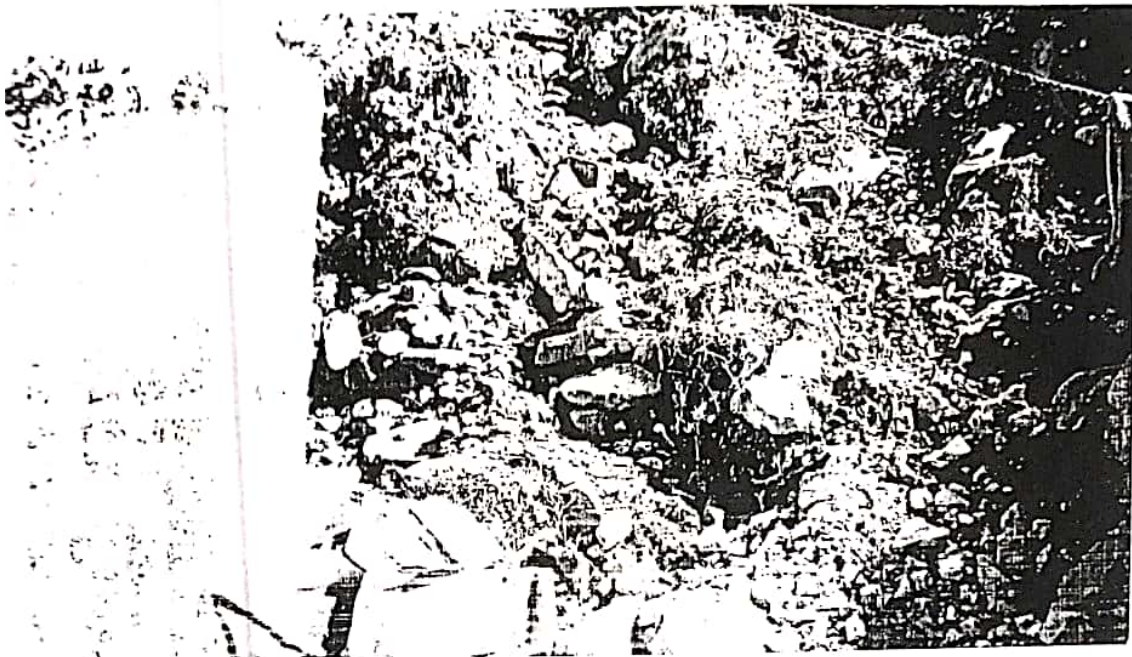
leads to greater seepage in the ground. The seepage can be seen from the house of Mr. Goverdhan Lal (Fig.22). A very deep (about 1 m) surface crack trending N275° with width of 16 cm and length 34 m has been noticed and within one year, the area has subsided from 30cm to 2mt.(Fig.23). The transverse and longitudinal cracks (Fig. 24) in the body of the slide zone have been noticed which have lead to subsidence effect, evident from the field observations at the crown and at the foot level of the slide zone. This is also an old slide zone showing a high degree of movement indicated by the subsidence of road below M.P. residence and damage to the house of Mr. Goverdhan Lal since 1984. Still the activity is going on and recently leveling of the road has been done by overloading the crown with additional soil brought from other areas (Fig. 25). This will not only accelerate the rate of movement but also result in mudflows during rainy season, thus posing heavy risks to economy as well as life of the residents downhill of this slide zone.

The field observations at the toe of the slide zone also reveal that it is a rotational slide with highly wet conditions (Fig.22) and the slope becomes very steep below the house of Mr. Goverdhan Lal. The surface cracks of width upto 18 cm. have been noticed on the upslope direction of Mr. Goverdhan Lal's residence.

Fig. 22: A crack in wet slope mass, covered with slid debris in MPR slide zone

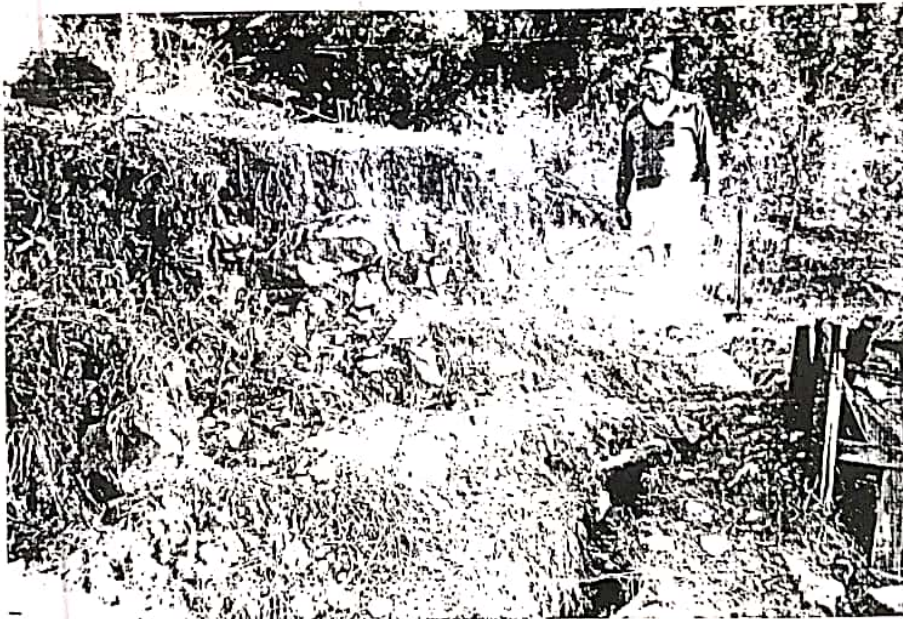
Fig. 23: Development of deep transverse cracks in the slide zone in MPR slide zone

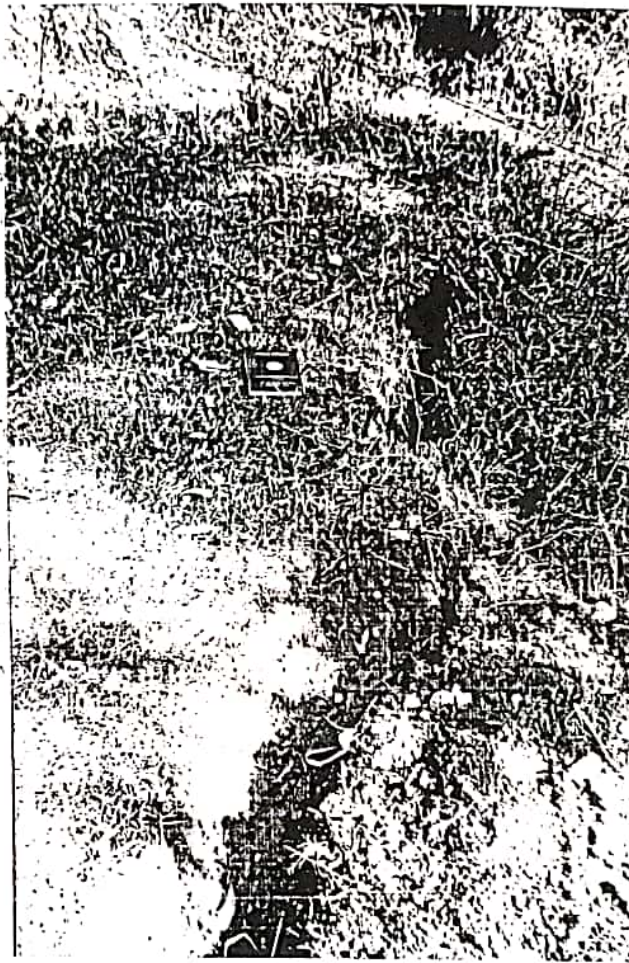
Fig. 24: Longitudinal and transverse cracks in MPR slide zone

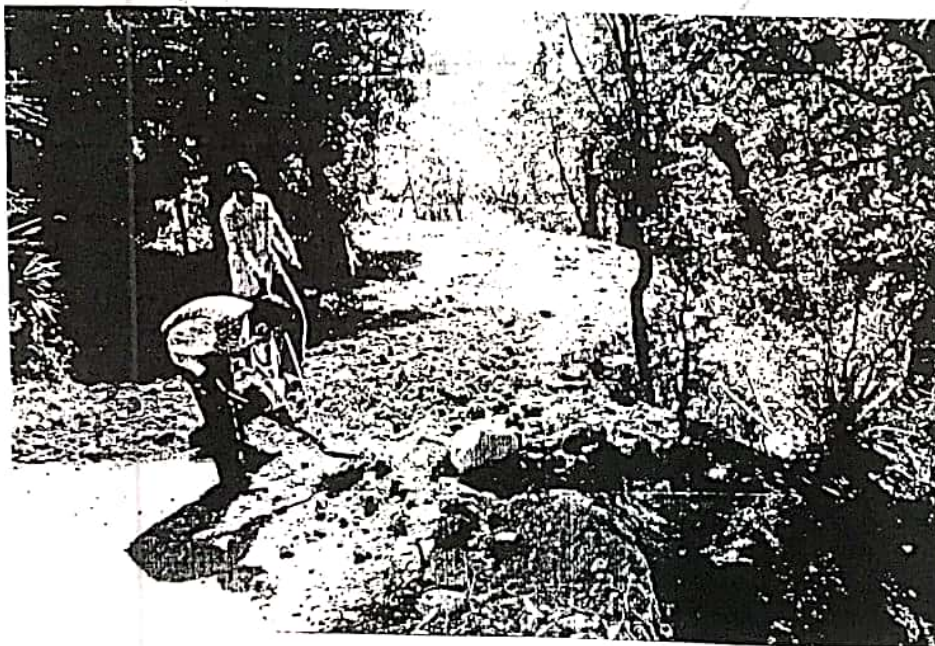
Fig. 25: Road subsidence and overloading of crown zone with soil, which may result in mudflows during rains in MPR slide zone

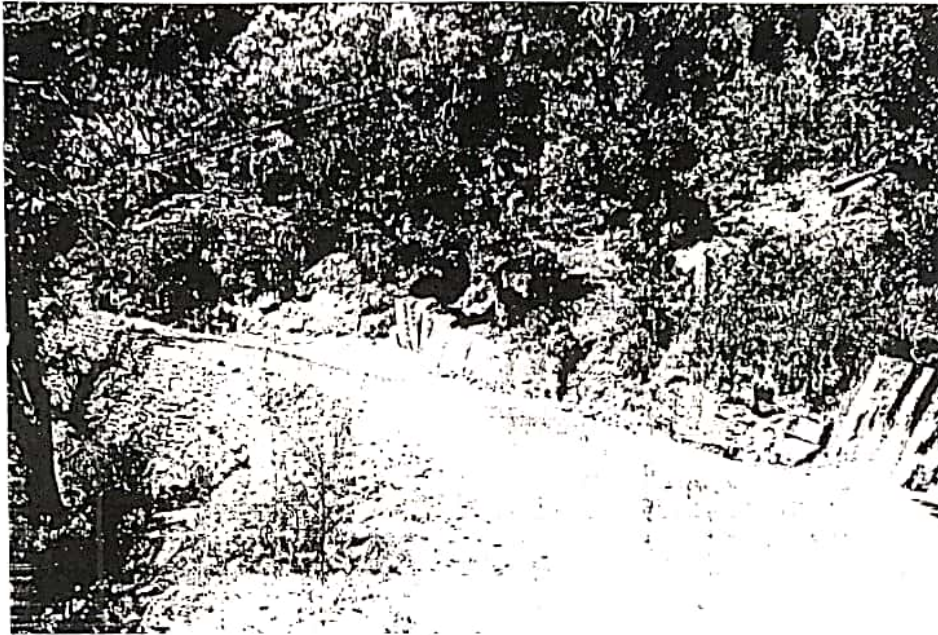
Fig. 26: Damage to artificial cemented drains on roadside Station HQ slide zone

The major causative factor of this slide zone is very high rate of seepage from the septic tanks, waste water disposal from upslide residential colony of the Army. So there is a need to channelise this water and also to redesign the existing concrete channel from Army Garage to the slide zone in order to reduce the runoff pressure that the damage occurring during monsoon season in the area is reduced.

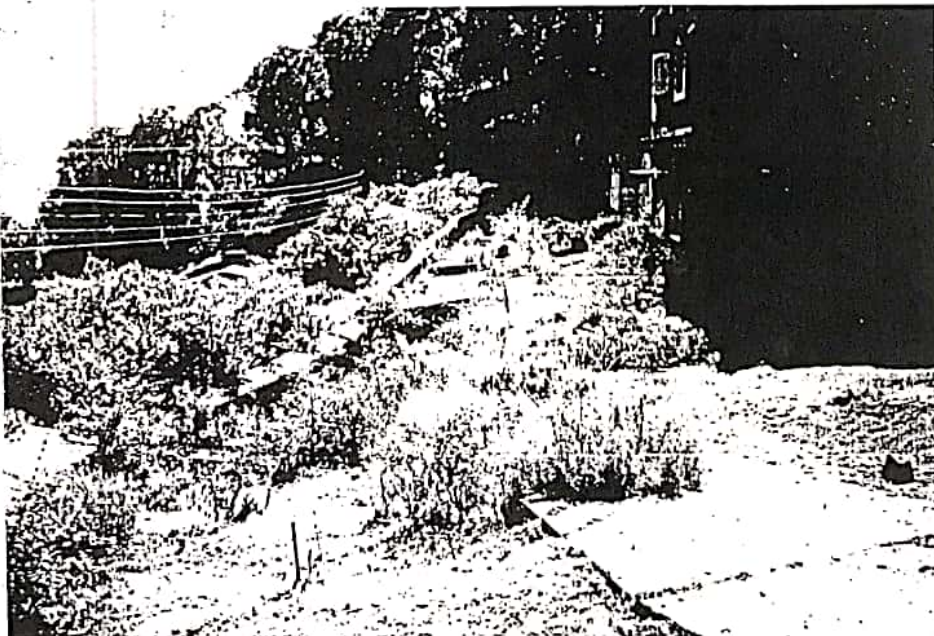
Fig. 27: Displacement in boundary walls of Station Headquarter residential buildings

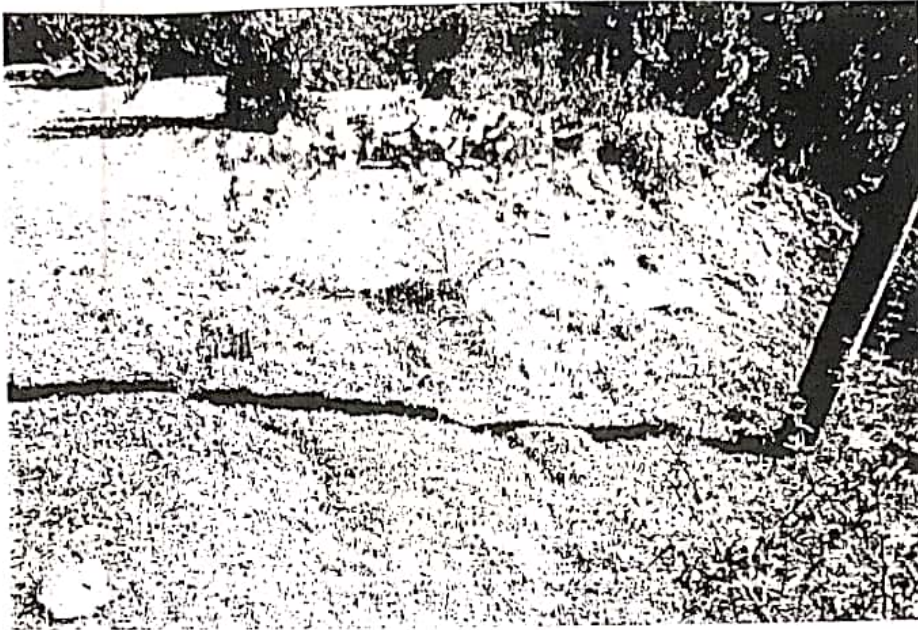
In the lower portion of the slide zone an artificial drain has been found displaced by from 3-5 m (Fig. 28), thus, showing a very high rate of movement. The slip surface also passes through claystones which is very well exposed at the toe of the slide zone where one can find huge amount of water gushing from the slip surface although the upper slopes are damp to wet in nature. Since there is already seepage at the slip surface which has generated number of longitudinal as well as transverse cracks on the surface (Fig. 29). A heavy rainfall in the area always triggers land movements. Side cutting and toe cutting during rainy season also promotes failure.

Fig. 28: Development of transverse and longitudinal cracks due to creep movement in Station Headquarter slide zone

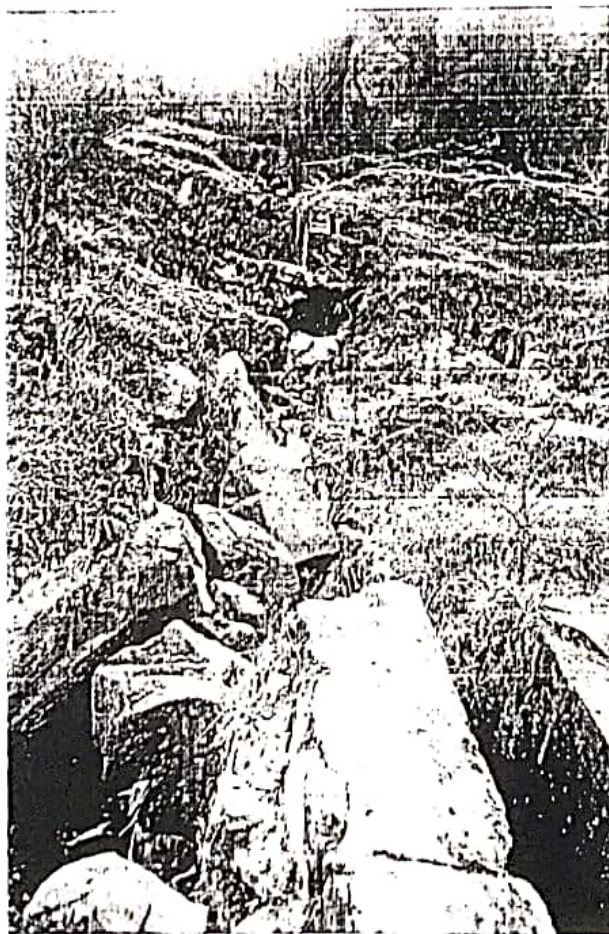
Fig. 29: Displacement (5 - 7m) in artificial drains at Station Headquarter slide zone

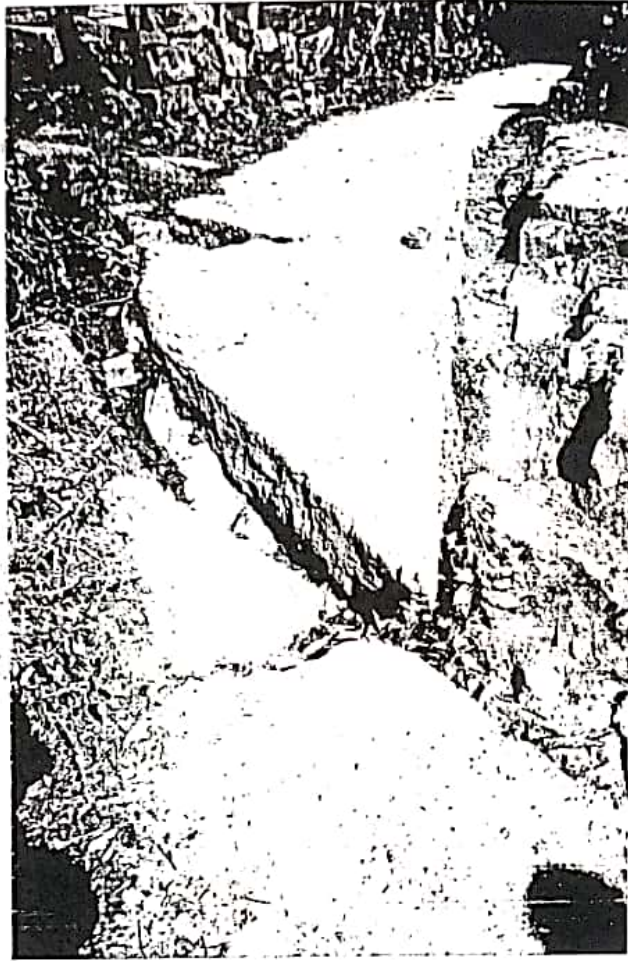
mass movement (Fig. 30) besides damage to house of Pandit residing in the area (Fig. 31) and movement was noticed in the house of Minor S.S. Nepali. The main building of the Major Nepali has moved south-southwest whereas his bathroom also indicates shift in their position, which is very well evident from the position of pucca drains in this house and narrowing down of the footpath from 4 feet to 2 feet, located between house of Mrs. Chandrawati and Major Nepali on the west of a natural drain. Even the other parts of the building like pillars attached to roof shades and roof axis on the top of the house have shown gaps due to downward movement of the slope mass in this area. On the northeast side of the natural drain and west of Dal lake nala, the area is moving downwards i.e. in the slope direction.

Fig. 30: A shift of 10 -12 cm in the cemented path in Totarani village

The remedial measures like proper sewerage disposal and appropriate drainage controls for uphill slope water along the road following slope, proper disposal of daily waste water to be organized by the local residents and plugging of seepage from Dal lake requires due attention. The landslide hazard map and risk map shows very high hazard and very high risk to the residents of this area.

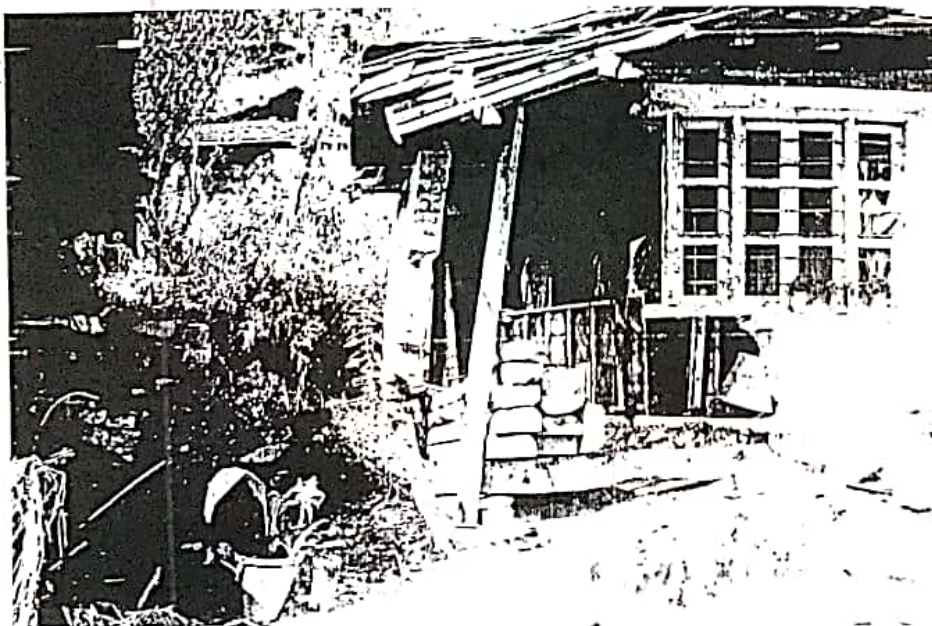
Fig. 31: Floor subsidence and building damage due slope failure in Totarani village

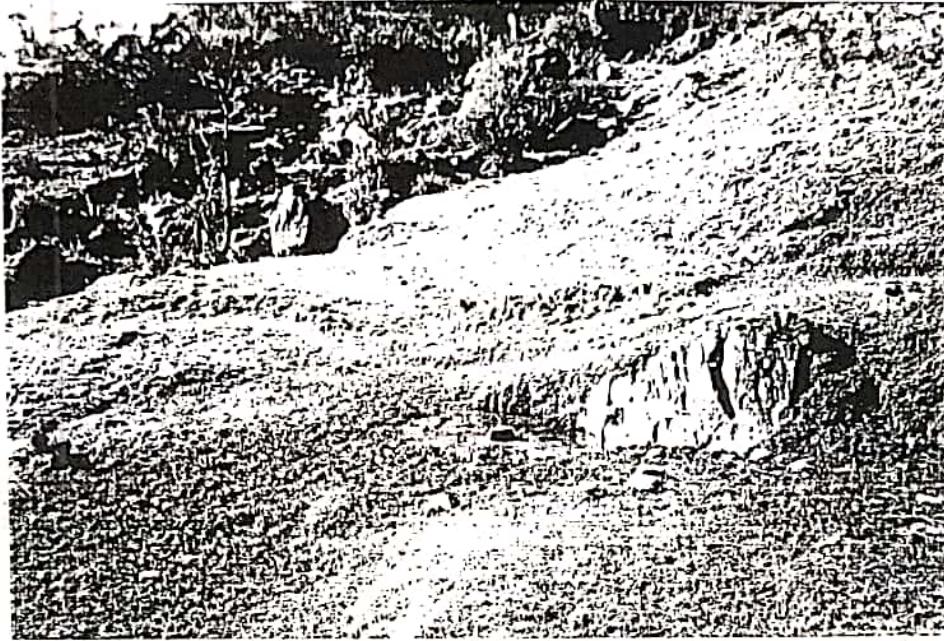
Fig. 32: Accumulation of water due to seepage from slopes in Totarani village

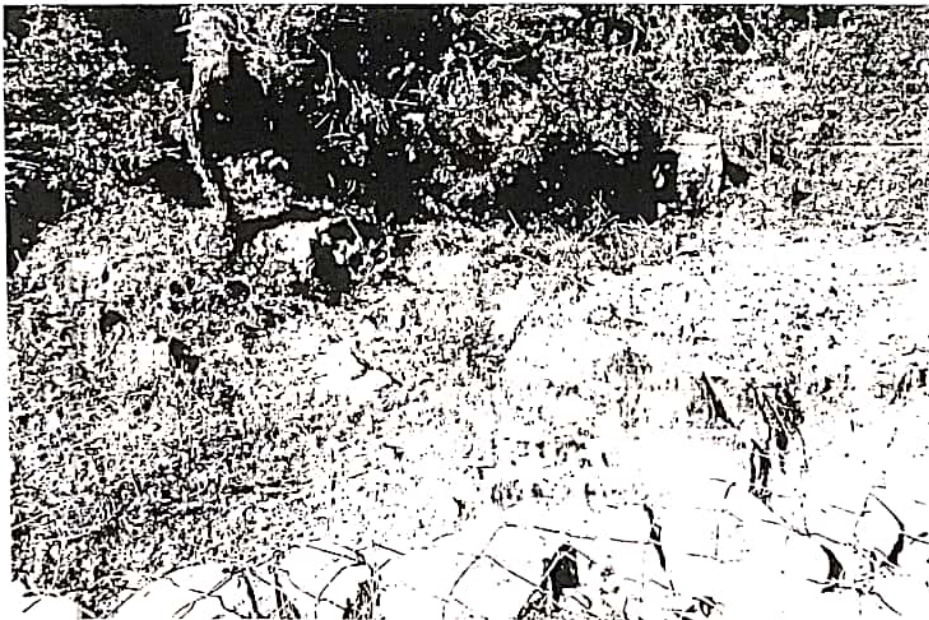
Fig. 33: Water accumulation due to seepage from slopes in Jogiwara slide zone

In the Jogiwara slide zone, the seepage from wastewater disposal and septic tank disposal is the main causative factor and rainfall only triggers or accelerate the movement. It has also been noticed in the field that the Hume pipe fitted below the road to drain out upslope water has been left open in the body of the slide zone which also cause heavy soil erosion and seepage and leads to sliding. In order to reduce the movement in this slide zone it is necessary to plug the seepage and divert the natural drain in the hume pipe so that there should not be any seepage in the body of the slide zone. Secondly the septic tank disposal and wastewater disposal of the Dalai Lama Temple Complex has to be channelised with proper sewerage system in the Dharamsala township.

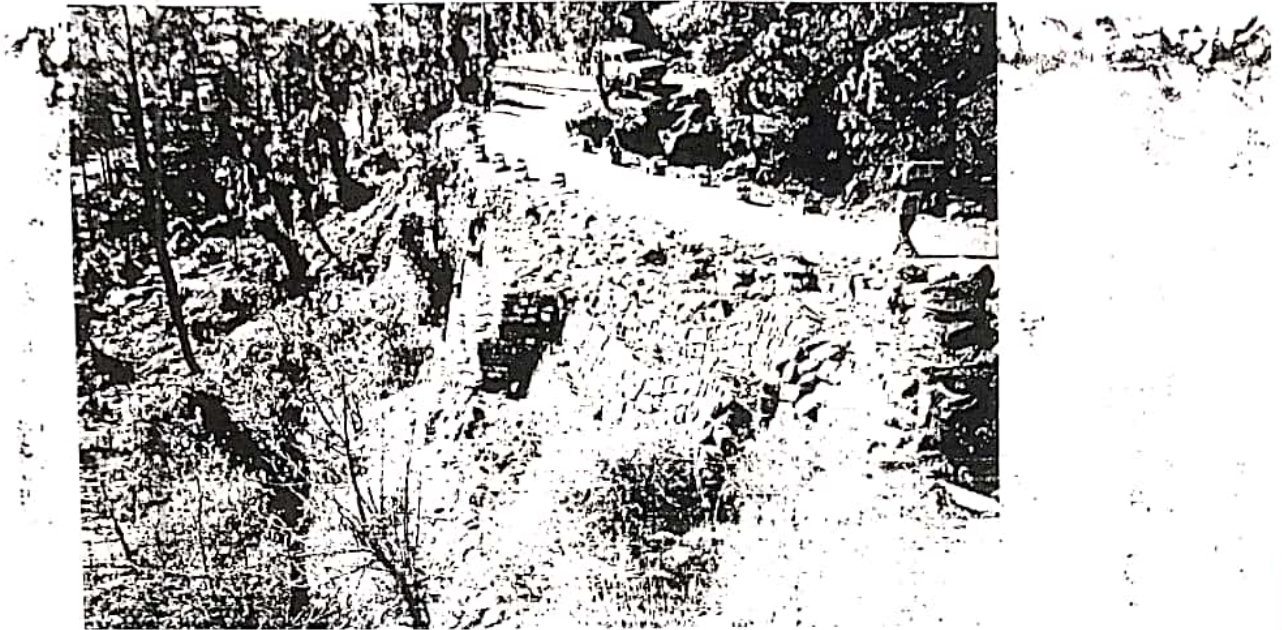
Fig. 34: Curvature in retaining walls indicating ground subsidence in Jogiwara slide zone

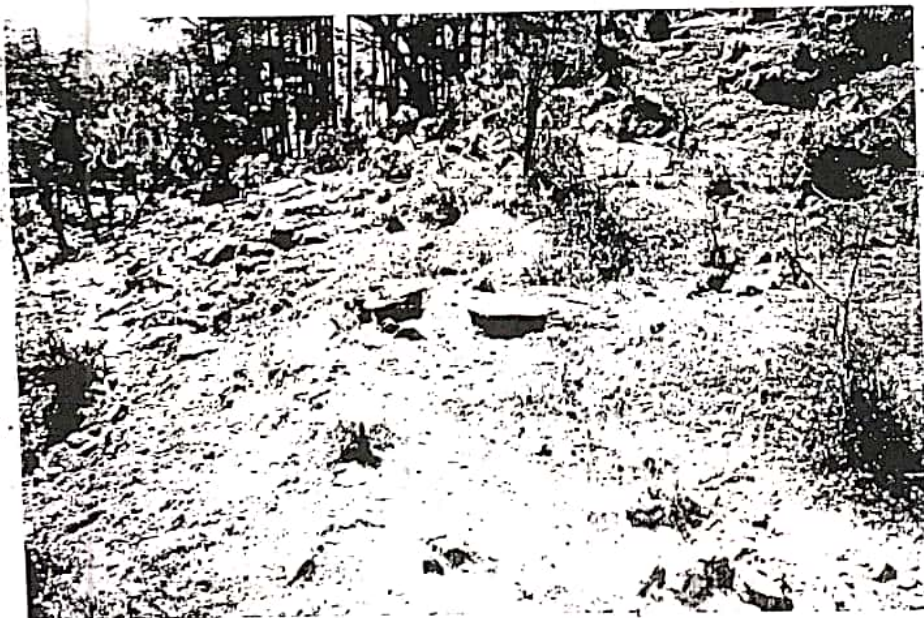
Fig. 35: Tilting of trees and disruption of road alignment in Gamru village in Jogiwara slide zone

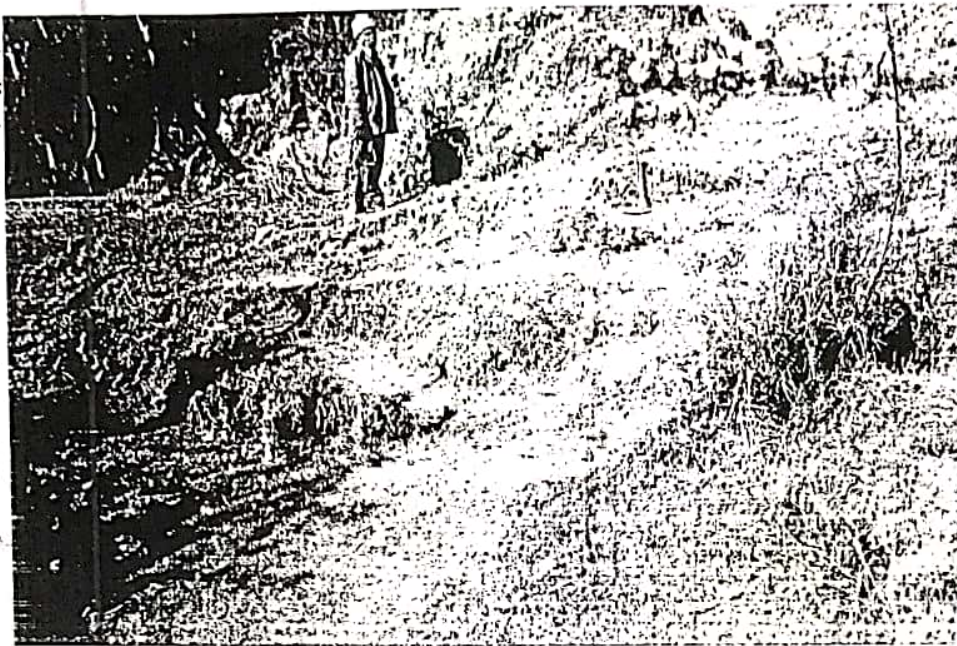
Fig. 36: Presence of benches and cracks indicating slope failure in Kajlot village

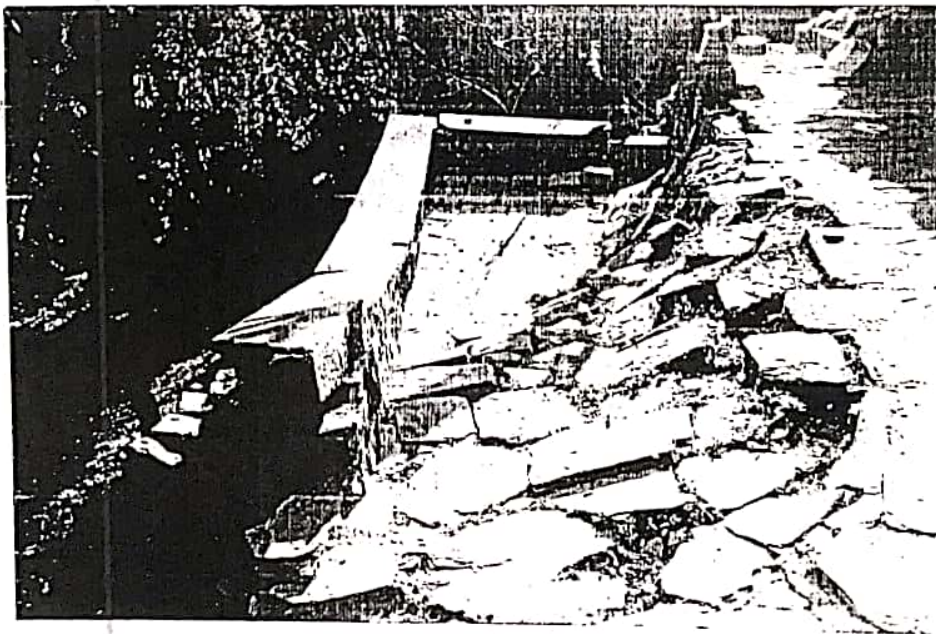
Fig. 37: Subsidence of floor and bulging of walls in Barakoti slide zone

The Barakoti slide zone and the parapet 163/3 zone have affected the road and the village Barakoti. Fig. 37 shows a clear cut displacement and subsidence of about 1 to 2 feet in the boundary walls of this village, as indicated by the distresses here. At the same time, the upper portion of the village Barakoti above which the main Dharamsala - Mcleodganj highway is located shows prominent scars and benches of land mass in the slide zone (Fig. 38), thus, making the road more vulnerable to the mass movements, posing high risk to the traffic. On the other hand the rainfall runoff from the Cantt. area to the road passing at parapet 163/3 causes much damage due to toe erosion (Fig. 39). In this slide zone, the major important aspect is to control the outflow of runoff in such a manner so that it should not be released just at the toe. It has been observed that almost all natural drainage channels passing below the road, no-one has been given a proper treatment for flow of run-off water and all the outflow has been left on the slope thus, leads to toe cutting. Thus, it is causing much damage during rainy season to the Dharamsala - Mcleodganj highway.

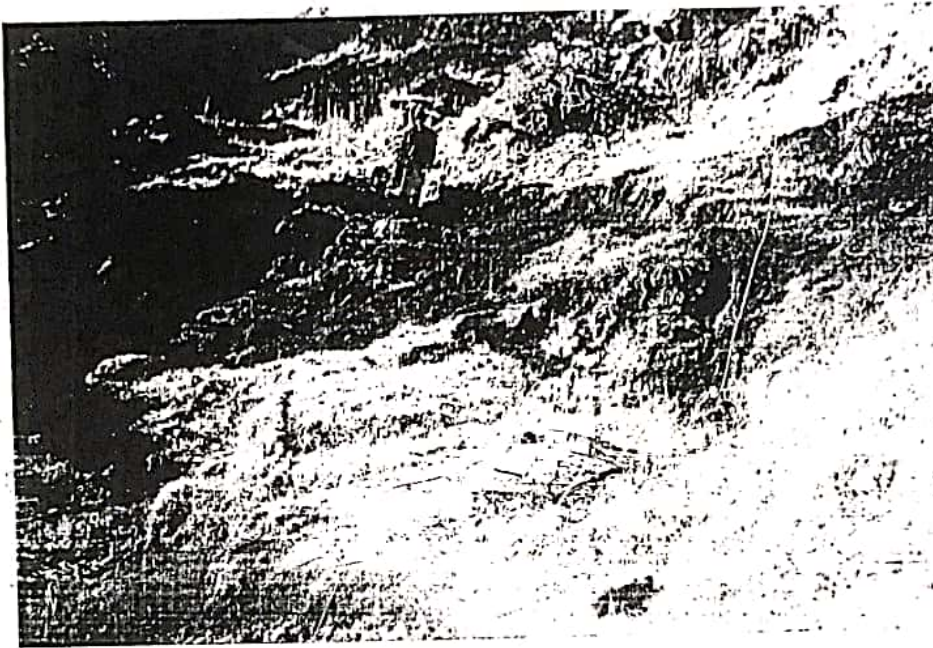
Fig. 38: Crescentic scar and cracks in Barakoti slide zone indicate slope movement

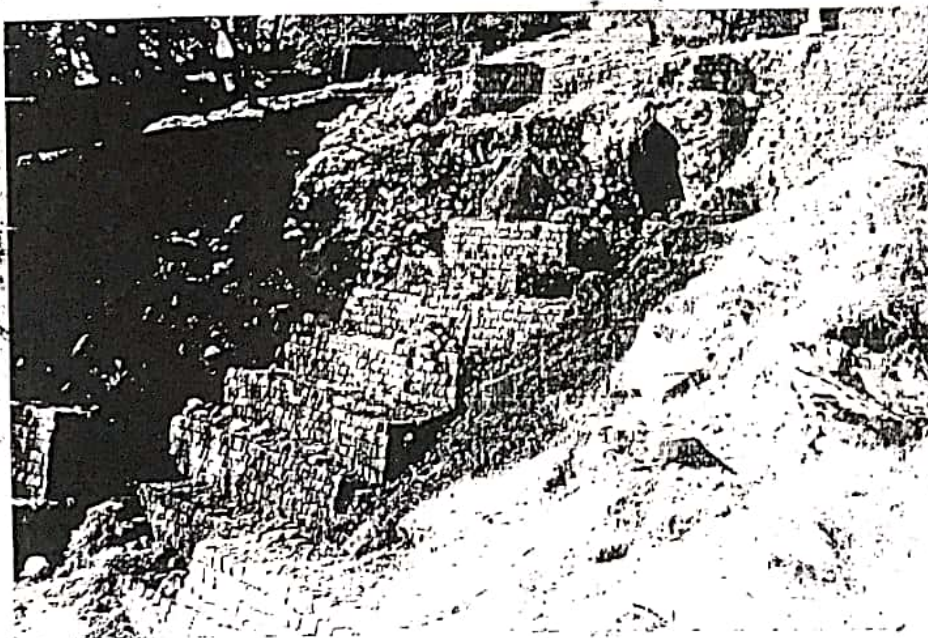
Fig. 39: Erosion at parapet 163/3 slide zone
