PRELIMINARY INVESTIGATIONS OF LANDSLIDES ZONES IN KANGRA AND CHAMBA REGION AS PER NOTIFICATION NO REV (DMC) (F) 11-09/2021- LM DEPARTMENT OF REVENUE (DM CELL), GOVT OF HIMACHAL PRADESH.

PROF. AMBRISH KUMAR MAHAJAN

CENTRAL UNIVERSITY OF HIMACHAL PRADESH

DATE: 26TH February 2024

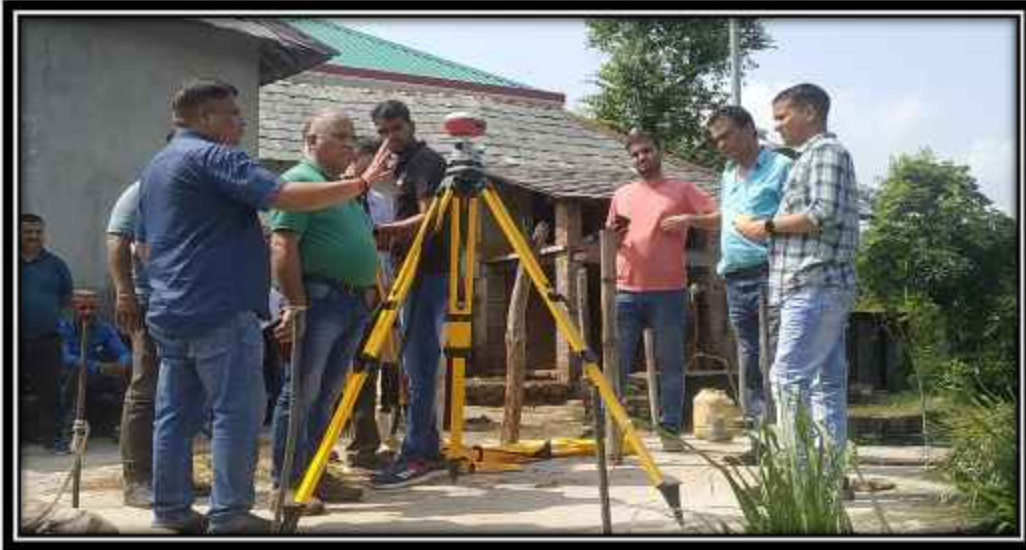
Fig. 2 Showing LiDAR Receiver setup placed at Parmar Nagar, Dheera-Nora Region during the preliminary survey by Central University of Himachal Pradesh Team.

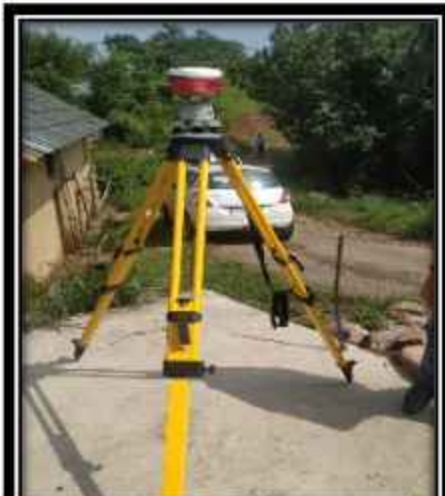
Fig3 showing LiDAR Receiver setup placed at Parmar Nagar

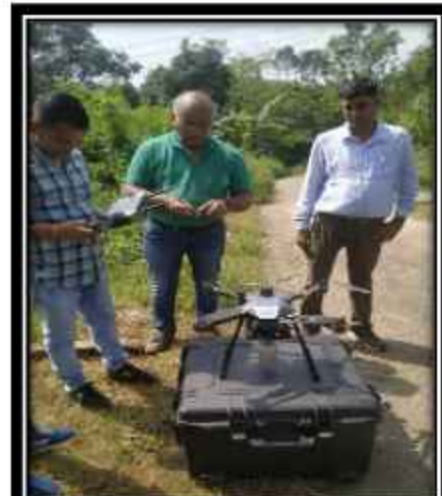
Fig 4 Showing Drone programming for the Survey

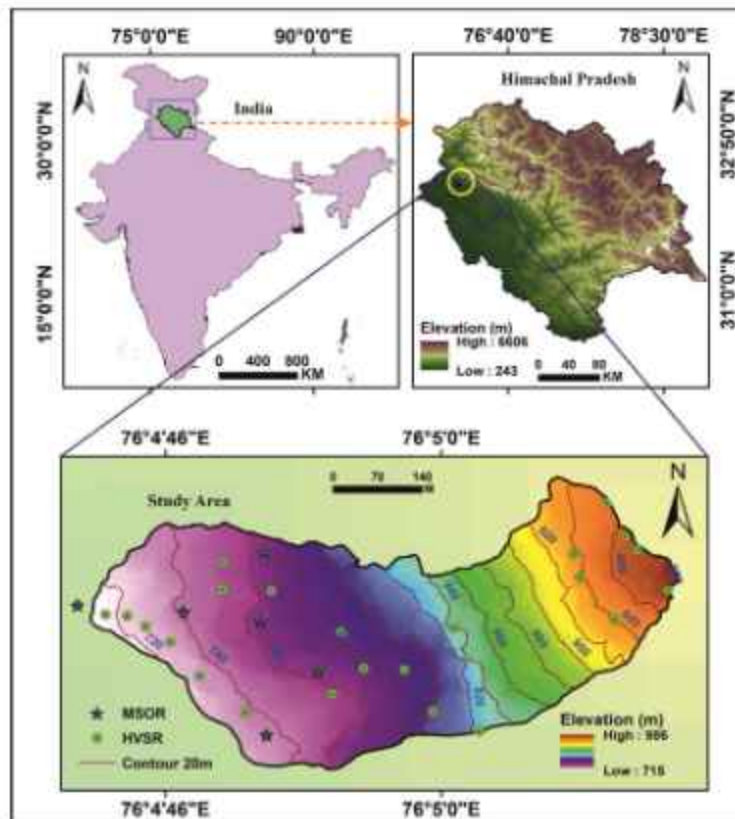
The Soldha slide zones fall to the north of Niangal village district Kangra, form a part of the Bhed watershed, and fall in SOI toposheet no 52D/3 (Fig.1). This slide zone is situated in the sub-humid climate of the Kangra region thus, experiences maximum rainfall during the monsoon season, spanning from July to September. The Soldha landslide zone is an integral part of the Bhed Khad watershed, where all tributaries converge into the Beas River basin. It falls within the sub-humid regime, receiving an annual rainfall of up to 1750 mm, primarily concentrated in the monsoon months. Extending over 0.78 km along the displaced hillock, the landslide zone covers an area of 0.25 km², exhibiting altitudinal variations from 715 m at the toe to 977 m at the scarp zone (Fig.17)

Fig. 17 Shows the location of Soldha slide zones (lower picture) in Himachal Pradesh, India. The location of the site covered under Horizontal-to-vertical spectral ratio (HVSr) analysis as green circles and multiple simulations with one receiver (MSOR) as a star are shown along with a contour interval of 20 m and elevation variation from 715 m (violet) to 986 m (dark mustard colour).

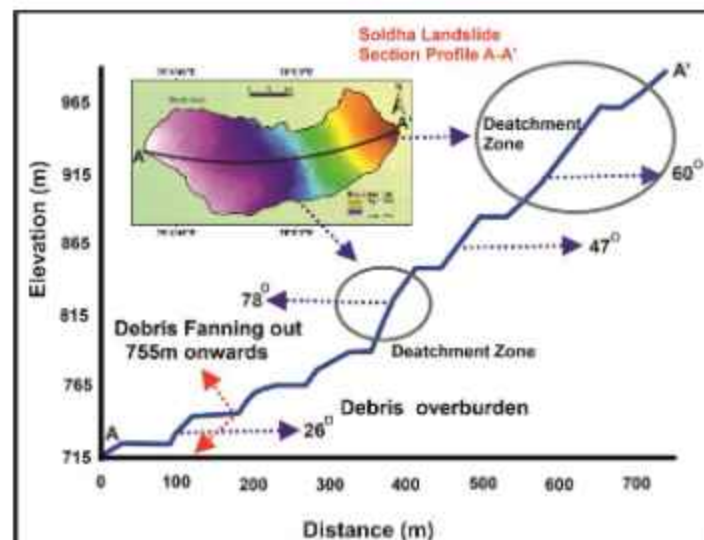
The slide is very steep at the crown part and has moderate slopes in the lower part, with elevation variations from 715 m at the toe to 977 m at the crown region within a distance of 0.78 km. The slope gradient along section A' (inset) indicates steeper slopes with break-in slopes at different parts of the slide zones. Fig. 18 shows the general trend of the hill at various parts of the slide zone. The detachment zones at the crown and first scarp and the areas with debris material at different parts of the slide zone are shown along the elevation profile.

Fig. 18 Cross section of the slide zone depicting elevation variation along the A-A' section
