PREPARATION OF LANDSLIDE HAZARD ZONATION
MAP OF DHARAMSALA TOWN AND ADJOINING AREA,
DISTRICT KANGRA (H.P.)

Title of Project: **PREPARATION OF LANDSLIDE HAZARD
ZONATION MAP OF DHARAMSALA TOWN &
ADJOINING AREA, DISTRICT KANGRA (H.P.)**

Report Period : March, 1999 to March, 2000

Name of Investigators : Dr. A.K. Mahajan
Dr. N.S. Virdi

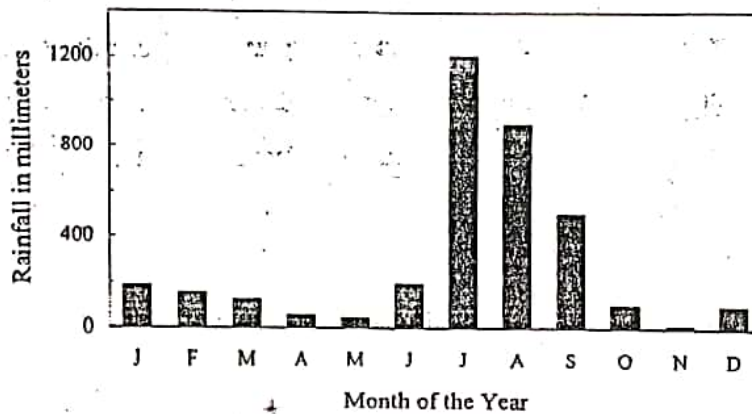
Fig. 5: Normal Monthly Rainfall in Dharamsala Region

The Dharamsala town receives maximum annual rainfall (260cm/yr) in the state. Most of which is confined between period from July to September. The fig. 5 shows the histogram of average monthly rainfall of the Dharamsala township. During 1997, a number of slide zones have been reactivated due to heavy rain fall, although in every rainy season the roads in Dharamsala-Mcleodganj tract have been subjected to subsidence and slide movement. These landslides have damaged or destroyed roads, water pipe lines, electrical and telephone transmission lines, houses

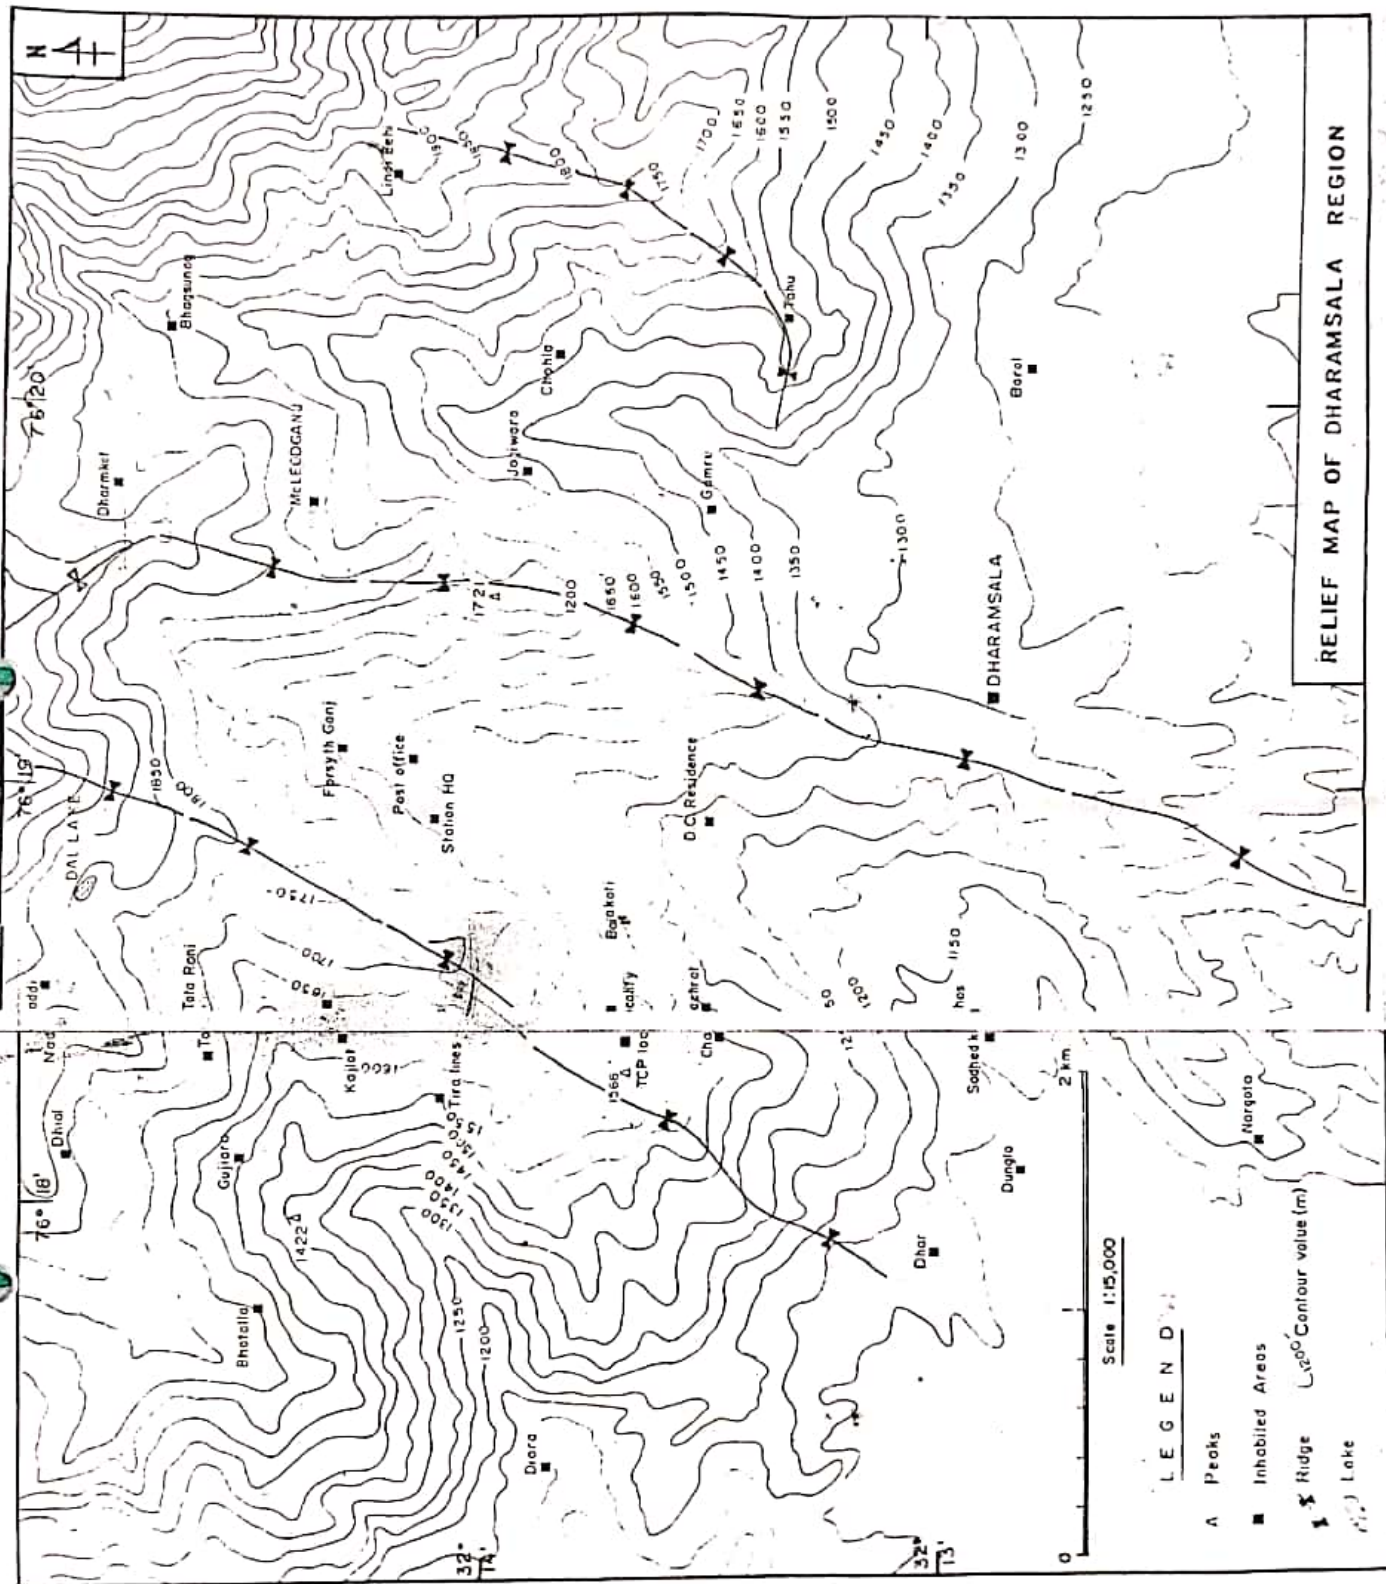
Fig 4

The relief map on 1:15000 scale (Fig. 4) of the region indicates that lowest relief is 1100 mt in southern and southwestern part of the area under investigation and highest relief of 2400 mt in the northeastern part of the study area. There are two major ridges running NNE-SSW direction and serving as a drainage divide between the Churan Khad and Banoi Khad. These major ridges also accommodate the population of the area and have lot of problems related to landslide.

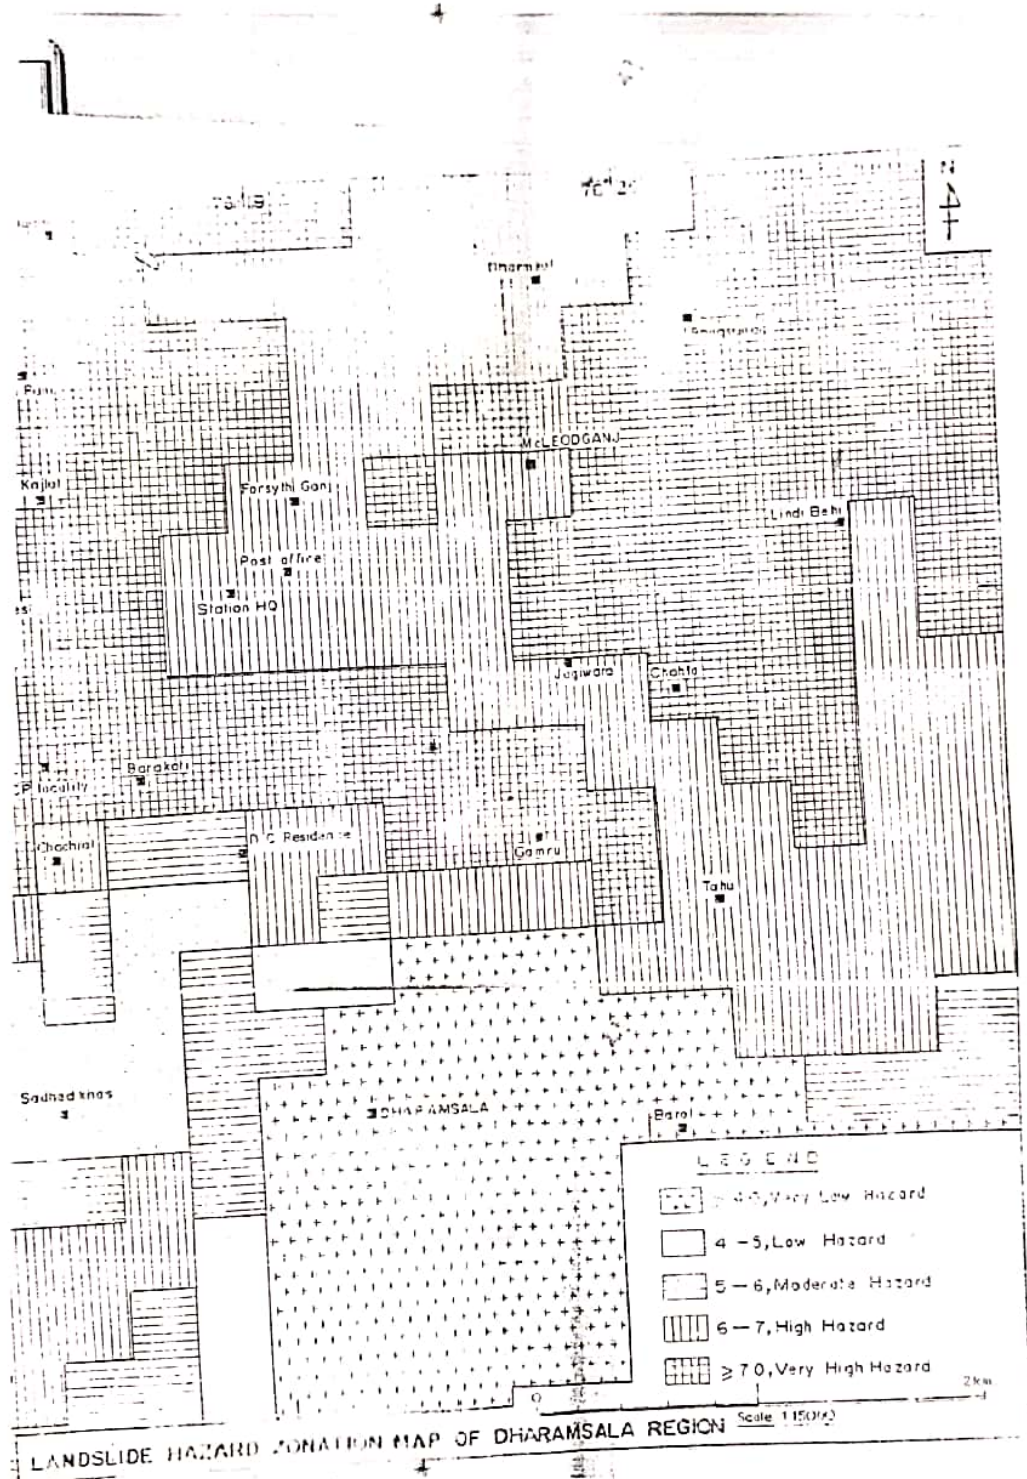
Fig. 40

A perusal of the landslide hazard zonation map (fig. 40) indicates that the northern slopes are relatively more unstable as compared to those in the southern part. It has been found that out of the total land area of 35.91% sq. km., about 32% falls under very high hazard zone, 31% under high hazard zone, 7% moderate hazard zone, 85 % low hazard zone and rest of the area (i.e. 21%) has very low hazard.
